TECHNICAL BULLETIN

T B 0 9 2 3 0 9

ATRO's UB20500 and New UB20500-OS in the Freightliner Air Liner II Suspension

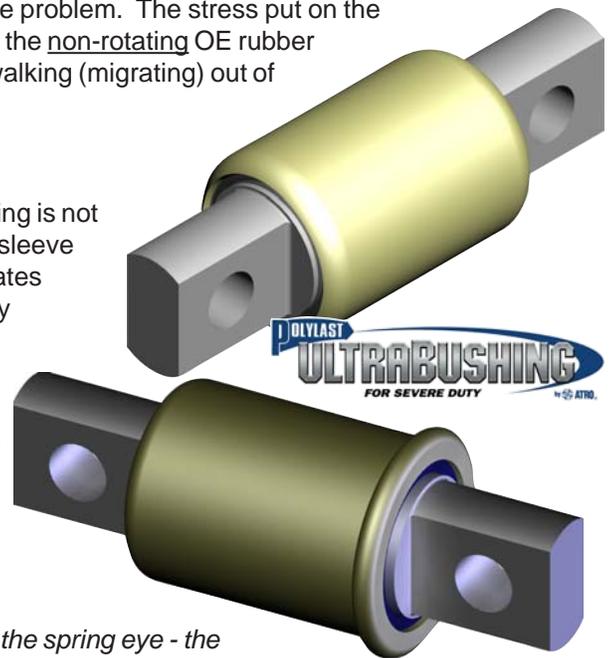
The OE *rubber* pivot bushing, RB205/RB234/RB268, for the Freightliner Airliner II suspension has had problems with the bushings rotating and migrating out of position within the eye of the spring. This was due to the spring eye weakening with stress and use causing the eye to open up beyond the OE specifications. As the eye of the spring gets larger, the grip on the bushing gets correspondingly weaker and the bushing will begin to rotate and walk out of position. The most recent OE *rubber* bushing design, the RB268, is crimped (one end) with the opposite end flared to prevent the bushing from migrating out of the spring when the eye begins to weaken. However, this OE rubber bushing does not address the root causes of the problem. The stress put on the spring eye and the wear due to the suspension articulation and the non-rotating OE rubber bushing pin results in the entire bushing rotating and laterally walking (migrating) out of position.

If any UB 20500 or UB20500-OS is found rotating freely within the spring eye - the entire bushing, not just the pin - the cause is a worn spring eye. ATRO strongly recommends spring replacement.

UB20500 with our original unique rotating pin design, if the spring is not worn out and the eye has not already been enlarged, the outer sleeve of the bushing will stay securely in place while only the pin rotates within the body of the bushing. (ATRO's UB20500 bushing only requires approximately 25 - 40 ft. lbs. of torque to rotate the pin.)

NEW UB20500-OS – our unique rotating pin design, oversized, anti-walk bushing. This bushing is .060" oversized and takes up the gap in most enlarged eyes. ATRO is offering a one-year warranty on the oversized bushing.
