Transmission Input Bearing Retainer

Clutch Cover / Intermediate Plate

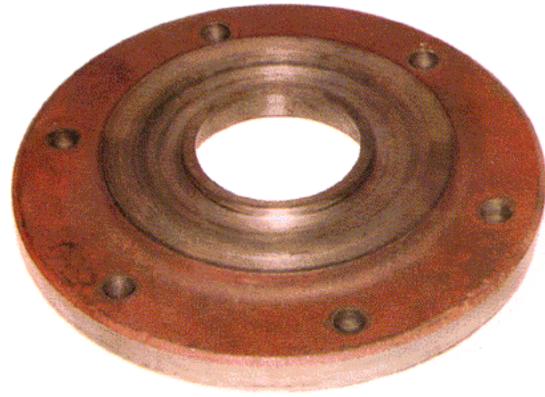
Figure 82

Worn Surface

Driver Notices: The transmission is hard to shift into first and reverse gears.

Observations: Outer surface is worn with deep grooves and scratches. The wear is “cupped” towards the center of the retainer.

Causes: Normal wear. Also, the driver may be engaging the clutch brake when the vehicle is moving or trying to override drag from a seized pilot bearing.

Correction: Replace the transmission input bearing retainer. Inspect the clutch brake and replace if required. Inspect the pilot bearing and replace if required. Make sure the driver uses the clutch brake correctly. This condition is not covered under warranty.

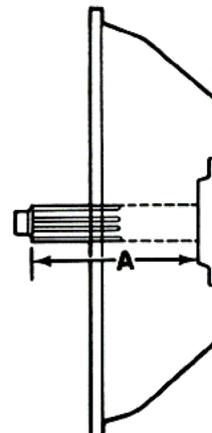
Figure 82A

The transmission input bearing retainer can also be checked by measuring the distance from the top of the splines on the input shaft to the top of the bearing retainer as shown in Figure 82A. The TARGET distance for the input shaft is 8.657 inch (219.9 mm). The dimensions are based on SAE Standard J-1463 from the 1994 SAE Handbook, 36.120.

IF DIMENSION 'A' IS MORE THAN 8.72 INCHES (221.48 mm), REPLACE THE INPUT BEARING RETAINER

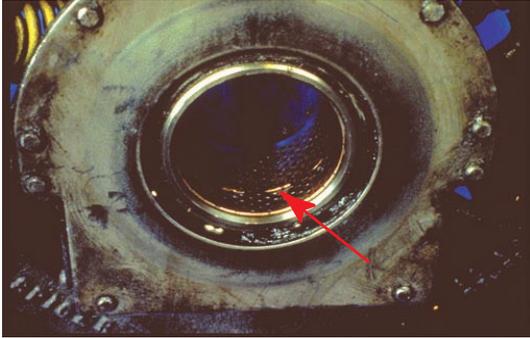
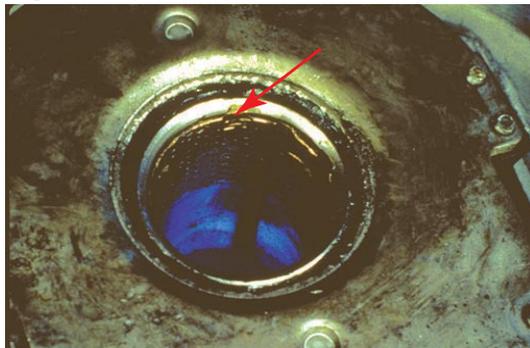
Failure - Damaged Sleeve Bushing

Failure to center the input shaft with the sleeve of the release bearing assembly, when installing the transmission, can cause this failure. If the transmission hangs up during installation, investigate the cause before proceeding as excessive force can damage the bushing (see arrow in Figure 12). Allowing the transmission to hang unsupported in the sleeve bushing can damage the bushing. The arrow in Figure 11 shows another example of sleeve bushing damage on a heavy duty clutch.

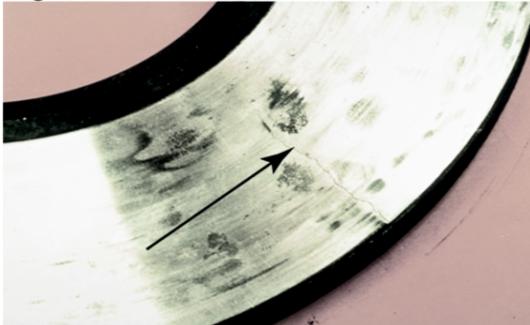
Fig 13

Figures 13 - 16 depict damaged clutch plates which resulted from an abnormal amount of clutch slippage/heat. Some causes of this abnormal slippage/excess heat can be one or more of the following:

1. Incorrect clutch applications. In otherwords, the engine's torque rating exceeds the clutch's torque rating.
- Driver abuse. (refer to Factors that Effect Clutch Performance Sections concerning the specific driver practices that can lead to excessive heat).
- Improper/ inadequate clutch adjustments. More specifically, operating the truck without free-play for extended periods of time; adjusting the clutch via the linkage instead of the required internal adjustment.
- Overloading of the vehicle.

Figure 13 is an example of a cracked pressure plate. The heat flow was so great that the metal could not dissipate it quickly enough.

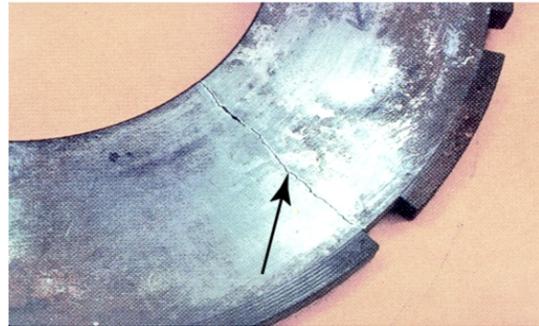
Fig 14

Figure 14 shows a broken intermediate plate. As in the previous example, the heat flow was so intense that the metal could not disperse the heat quickly enough.

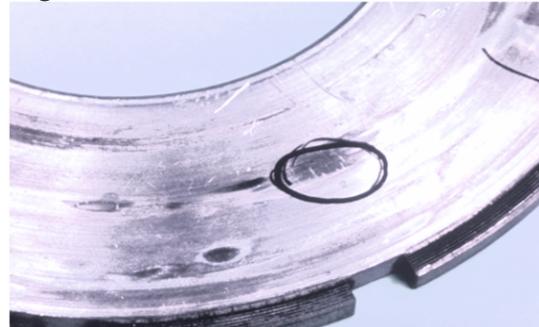
Fig 15

In Figure 15, an area of the intermediate plate has been circled to reveal the damage of heat checks. These heat checks are actually small cracks with raised ridges that are capable of shaving off the facings of the driven disc.

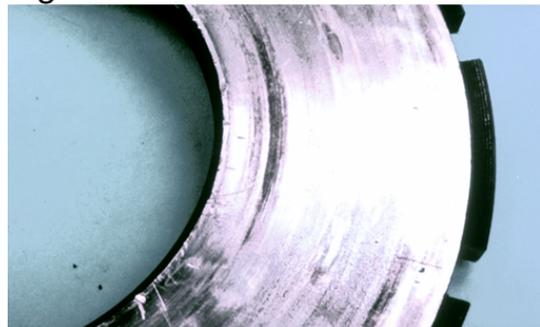
Fig 16

Finally, Figure 16 reveals an example of a burned or scorched intermediate plate in which the metal became so hot that it began to flow. The typical evidence of such a failure will be one or more of the following:

- High and low spots on the plate
- Partial transfer of the facing material (ceramic or organic) from the driven disc onto the plate
- A blue discoloration throughout the failed part

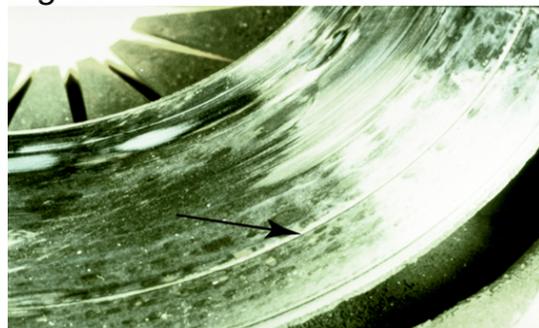
Fig 17

The groove (see arrow in Figure 17) worn into the face of this pressure plate was caused by the rivets of the driven disc facing. (For the related disc failure, see the description under Figure 70). The same damage can occur on both the intermediate plate and flywheel. A surface that is grooved can damage the new driven discs that are installed. As a result, a new clutch assembly should be installed. Refer to the OEM service manual concerning flywheel resurfacing.

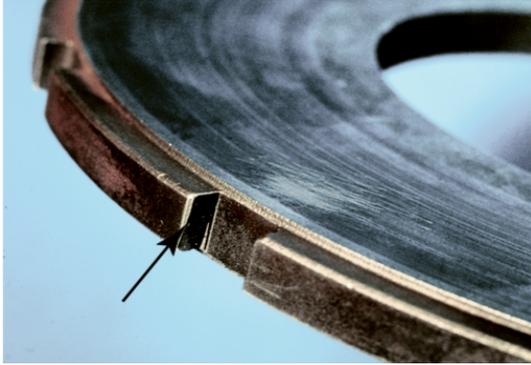
Fig 18

Failure - Cocked Drive Pins (14" Pot-Style Clutches Only)

The groove worn in the face of the drive pin slots are on the upper section of the face on one side of the slot (see arrow in Figure 18) and on the lower section on the opposite side of the slot. This indicates that the drive pins were cocked and causing the intermediate plate to hang-up. This will cause release problems and therefore hard shifting. Do not file the slots of the intermediate plate to correct the problem. Instead, you must reset the drive pin(s) until they are square to the flywheel.

Note: Always install new Eaton drive pins when installing a new Eaton Fuller 14" Heavy Duty Clutch. This is important because worn drive pins (against the new intermediate plate slots) can prevent the clutch from releasing cleanly. Also, ensure that the drive pins are set squarely to the flywheel's friction surface (refer to the Eaton Installation Instructions packaged with each Eaton Fuller Clutch). Failure to set each drive pin squarely is the most prevalent reason for a "poor release complaint" on a recently installed clutch (Angle Spring and Easy-Pedal Plus 1402).

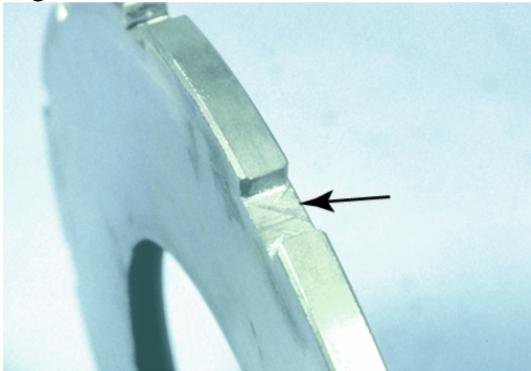
Fig 19

Failure - Filed Drive Slots

As indicated by the shiny areas on the drive slots, (see arrow Figure 19) the slots of this intermediate plate were hand filed. Eaton does not recommend this practice since it can cause unequal loading on the drive pins in the flywheel. Instead, Eaton recommends that the drive pins be checked for squareness to the flywheel friction surface and reset if necessary (see Eaton Installation Instructions).

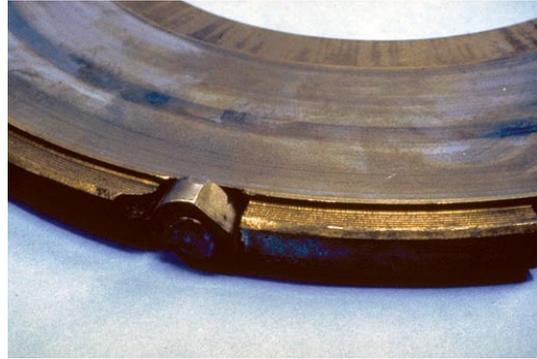
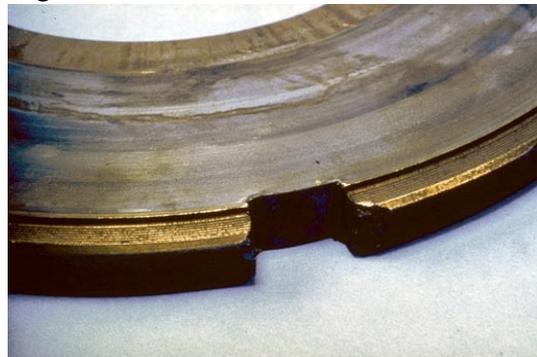
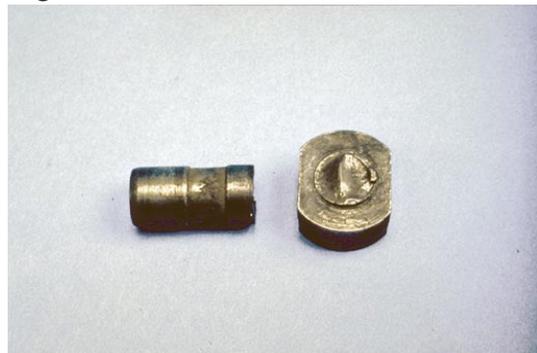
Failure - Broken Drive Pins and Worn/Broken Drive Slots (14" Pot-Style Clutches Only)

Figure 20 shows a broken drive pin head that has become wedged into the intermediate plate's drive slot. Figure 21 is the same intermediate plate but with excessively worn and broken drive slots. Figure 22 shows a broken drive pin. The above failures can be caused by one or more of the following:

- Failure to use the anti-rattle springs packaged with each super-duty clutch
- Misapplication of the clutch
- Unequal loading on the drive pins as a result of filing the drive slots.

Note: Failure to use the anti-rattle springs can cause other problems such as a noisy or poor releasing clutch.

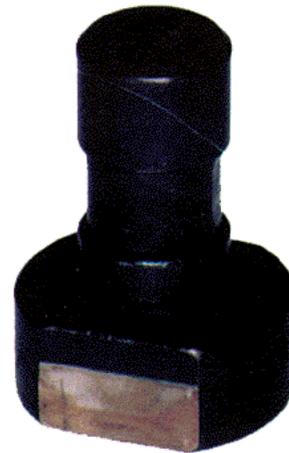
Figure 49

Normal Wear

Observations: Wear pattern is in the shape of the drive pin in the slot of the center plate. Drive pin shows even wear.

Causes: Normal wear.

Correction: Move center plate to next slot over drive pin during installation. If all slots are worn, replace plate and pins. This condition is not covered under warranty.

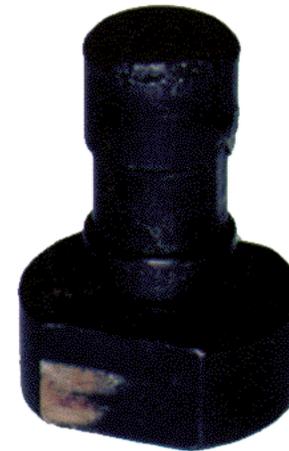
Figure 50

Not Correctly Installed

Driver Notices: Clutch may drag and/or slip.

Observations: Wear pattern is only in one area of the drive pin and slot.

Causes: Drive pins not correctly installed (cocked).

Correction: Replace drive pins. Use an installation tool to install pins. Move center plate to next slot during installation. If all slots are worn, replace center plate. This condition is not covered under warranty.

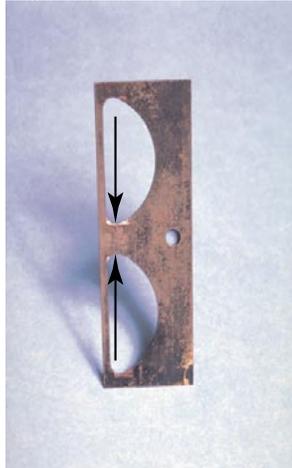
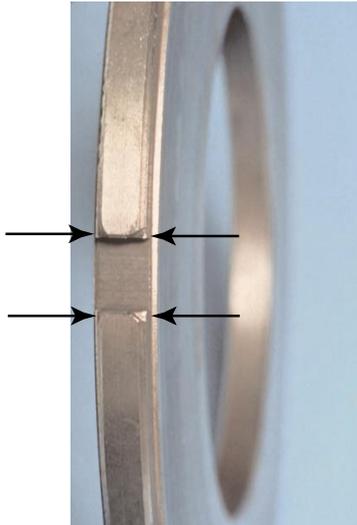
Failure - Anti-Rattle Springs Installed Backwards

As shown in Figures 23 and 24, the intermediate plate was “hanging up” at the corners of the open sections of the anti-rattle springs. The driver’s complaint was a clutch that would not release. It is important that the rounded flywheel/ engine sections of the anti-rattle springs be installed TOWARDS the flywheel/ engine.

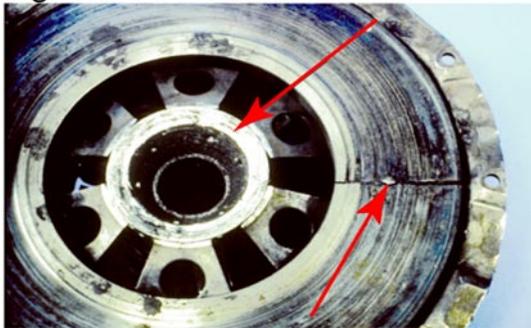
Fig 25

Failure - Interference Between Retainer Assembly and Rear Disc Rivets

Figure 25 shows the damage done to the nose of the retainer assembly (see arrow) due to contact with the disc rivets. Figure 57 shows the resulting damage done to the rear disc. Adjusting the clutch externally (with the linkage) instead of internally (rotation of adjusting ring) will cause the retainer sleeve/release bearing assembly to move too far forward as the clutch wears, leading to this failure.

An additional result from the above failure is that while the clutch is engaged, it can begin to slip due to the unloading condition created by the disc and retainer interference. This, in turn, will create excessive heat and can cause the pressure plate to break (see Figure 25, black arrow on pressure plate) and /or the ceramic buttons to separate from the disc (see Figure 58). The above failure may also be preceded by a noise complaint.

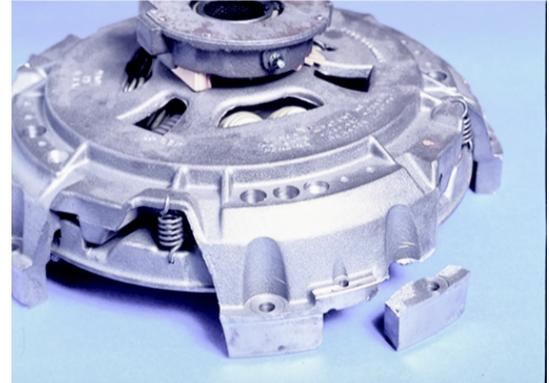
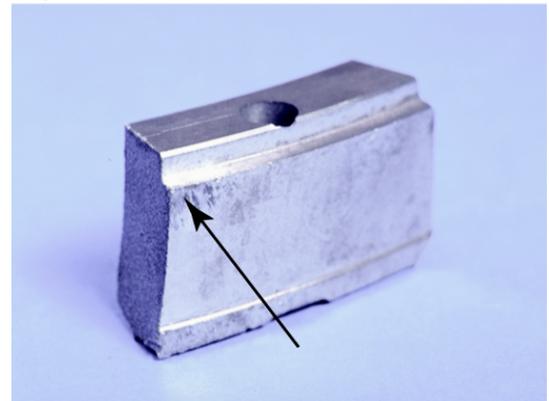
Failure - Broken Leg

- Abusing the clutch during shipping and handling.
- Dropping the clutch during installation or removal.

The photo in Figure 27 is a close-up of the broken leg shown in Figure 26. The arrow in this close-up shows where the leg contacted the concrete floor after the clutch was dropped.

The use of “guide studs” plus a “hydraulic clutch stand” will help prevent this 150 lb. clutch from being dropped during installation and removal.

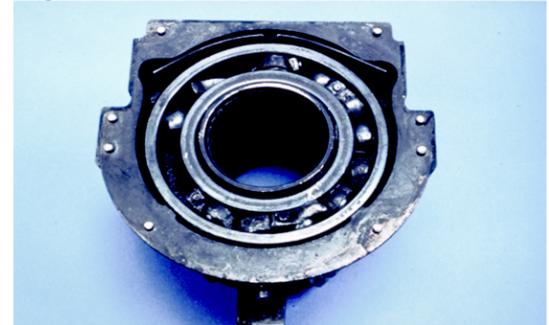
Fig 28

Failure - Release Bearing

A failed release bearing (see Figure 28) can usually be attributed to one or more of the following situations:

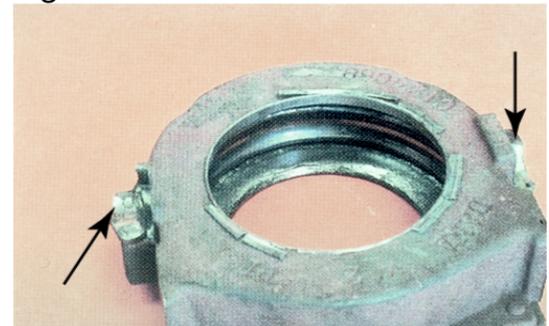
Fig 29

- A dry release bearing due to lack of periodic lubrication (does not apply to sealed bearings).
- Failure to fully release or riding the clutch pedal will place a constant thrust load on the bearing, (see arrows in Figure 29) leading to higher temperatures and consequential loss of lubricant. Failure to maintain free play up in the cab can also cause this condition. Not only will the bearing begin to fail, constant contact in this area will cause both the release yoke fingers (Figure 79), and the wear pads (Figure 29), to wear excessively.

- A potential result of this wear is that the release yoke will force the bearing and sleeve assembly against the input shaft. Consequently, this “side loading” condition can damage the bushing, sleeve, and input shaft (see Figure 78).

- Failure to use the recommended high temperature lubricant can also cause a loss of lubricant, even under normal operating conditions. An impending release bearing failure may be accompanied by noise.

Note: In order to determine the proper greasing techniques, be sure to consult the Eaton Installation Instructions packaged with each Eaton Fuller Clutch.

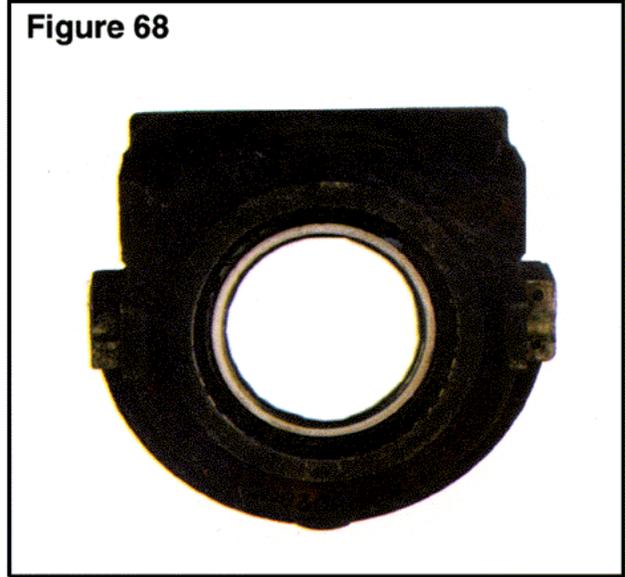
Figure 68

Severe Wear on Wear Pads

Driver Notices: Clutch pedal free travel does not exist. Hard shifting into first and reverse gears. Clutch does not disengage and slips. The clutch pedal is hard to push.

Observations: Round wear into (and possibly through) the wear pads. In more severe cases, the wear is into the body of the release bearing housing.

Causes: Release bearing clearance was never adjusted or the linkage was adjusted instead of the release bearing clearance. The release fork-to-pad clearance is not correct. Also, the driver may keep a foot on the clutch pedal.

Correction: Replace the release bearing housing or the clutch assembly. Make sure the clutch is adjusted internally. Check and adjust the release bearing clearance at regular intervals. Inspect the release fork. Make sure the driver does not keep a foot on the clutch pedal. This condition is not covered under warranty.

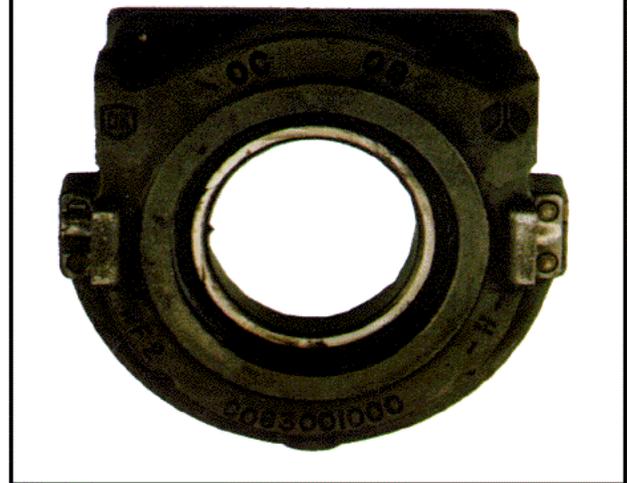
Figure 69

Wear Is Not Even on Wear Pads

Driver Notices: Clutch drags or is difficult to engage and disengage.

Observations: Wear is different on the wear pads on each side of the release bearing housing.

Causes: The cross shaft is worn or damaged or the bushings for the cross shaft in the clutch shaft are worn or damaged.

Correction: Replace the release bearing housing or the clutch assembly. Inspect the cross shaft, the release fork and the cross shaft bushings and service as required. Lubricate the bushings at scheduled intervals. This condition is not covered under warranty.

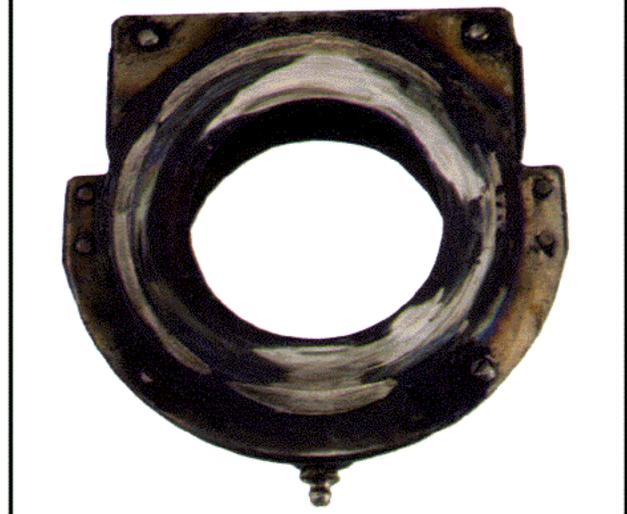
Figure 70

Burnt or Seized

Driver Notices: Clutch is noisy and difficult to engage or disengage.

Observations: Release bearing is severely burnt and may not rotate freely on the clutch assembly.

Causes: The release bearing is not lubricated at the specified intervals or with the correct lubricant.

Correction: Replace the release bearing housing. Inspect the release fork and replace if necessary. Lubricate the release bearing at the specified intervals with the correct lubricant. This condition is not covered under warranty.

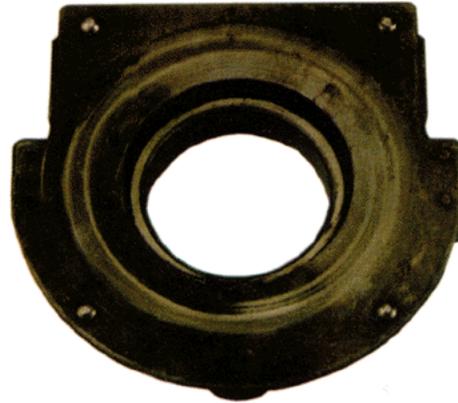
Figure 71

Bearing Housing Cover Wear

Driver Notices: Hard shifting and noise into first and reverse gears.

Observations: Heavy wear pattern is on the release bearing cover.

Causes: The release bearing clearance and/or the clutch linkage are out-of-adjustment or not adjusted correctly which cause the clutch brake to touch the release bearing cover. Also the driver may be engaging the clutch brake when the vehicle is moving or trying to override drag from a seized pilot bearing.

Correction: Replace the release bearing housing. Adjust the release bearing clearance and the clutch linkage. Inspect the clutch brake and replace if required. Inspect the pilot bearing and replace if required. This condition is not covered under warranty.

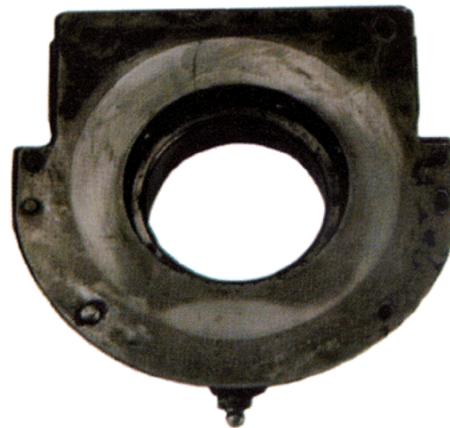
Figure 72

Cover Separates from Bearing Housing

Driver Notices: Clutch is noisy when engaged or disengaged.

Observations: The cover is separated from the release bearing housing.

Causes: Clutch brake squeeze may not be adjusted correctly. Also the driver may apply too much pressure on the clutch pedal.

Correction: Replace the release bearing housing assembly. Make sure clutch brake squeeze adjustment is correct. Make sure the driver operates the vehicle correctly. This condition is not covered under warranty.

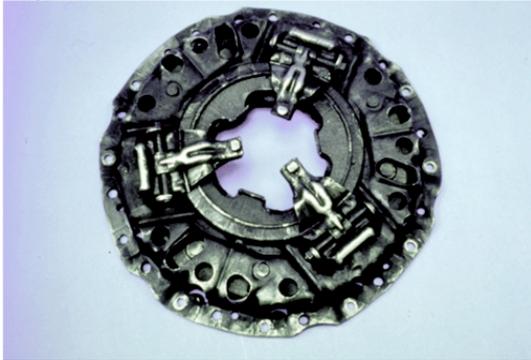
Fig 30

Failure - Oil Soaked Cover

A leaking transmission or a leaky rear main engine seal can coat the clutch cover with oil, as indicated in Figure 30. Figure 41 shows the disc which was run with this cover.

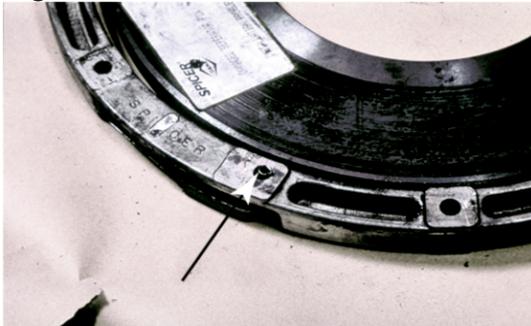
Fig 31

Failure - Bent/Damaged Positive Separator Pin

The separator pin shown in Figure 31 became damaged (bent) when it was dropped during clutch installation. To prevent this from occurring, Eaton recommends the use of two (2) guide studs when mounting the intermediate plate and clutch cover to the flywheel (refer to the Eaton Installation Instructions).

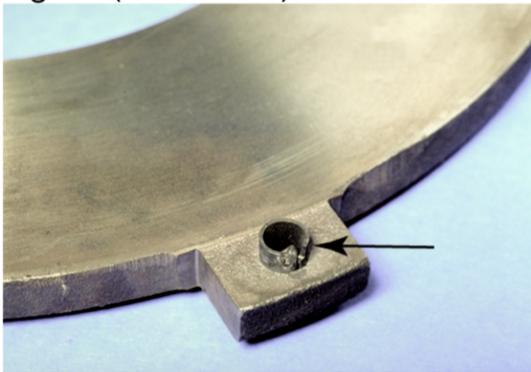
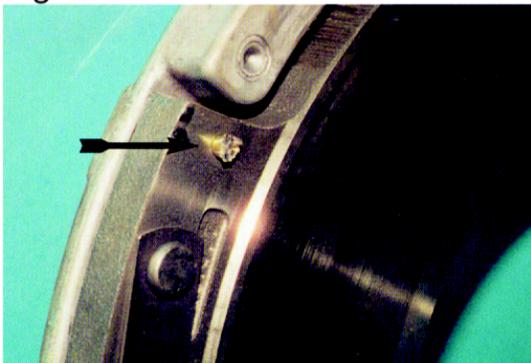
The damage done to the separator pins in Figures 32 and 33 (see arrows) is the result of using the wrong tool combined with excessive force. All four pins (on each intermediate plate) were damaged. When "setting" the four (4) roll pins, the proper tool would be a 1/4" flat nose punch used in conjunction with a small hammer (to help ensure light taps).

A damaged pin(s) can prevent the intermediate plate from retracting evenly when the clutch is disengaged, leading to a "poor release" complaint from the driver. The same complaint can also occur if the mechanic forgets to "set" the four (4) positive separator pins upon installation of the clutch. In you forgot to set the separator pins before installing the transmission, you can still set them through the inspection opening of the transmission.
