Center Plate

Failure - Aluminum Spacer Ring on the Intermediate Plate is Broken (Eaton Fuller Solo™ and Stamped Angle Spring 1402 only)

Clutch Disc Assembly Failures

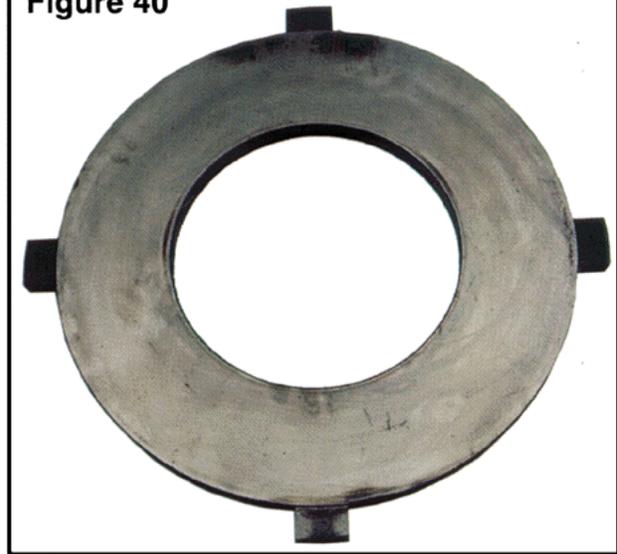
Figure 40

Normal Wear

Normal wear is a smooth and even wear on both sides of the plate. Minor damage such as heat marks can be removed with an emery cloth.

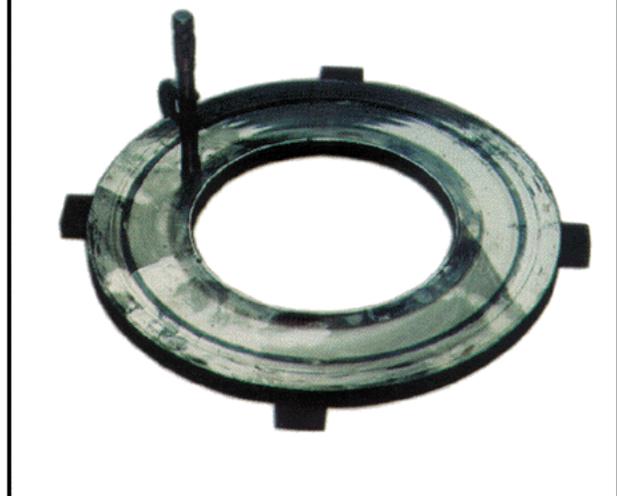
Figure 41

Too Much Wear

Driver Notices: Clutch slips.

Observations: The center plate must be replaced when the thickness of the plate is less than the following:

14 Inch Clutches With Ceramic Discs:
0.728 inch (18.5 mm).

14 Inch Clutches With Organic Discs:
0.610 inch (15.5 mm).

15-1/2 Inch Clutches: 0.681 inch (17.3 mm).

Causes: Center plate is not replaced at the correct interval.

Correction: Replace clutch assembly. Inspect clutch at regular intervals. This condition is not covered under warranty.

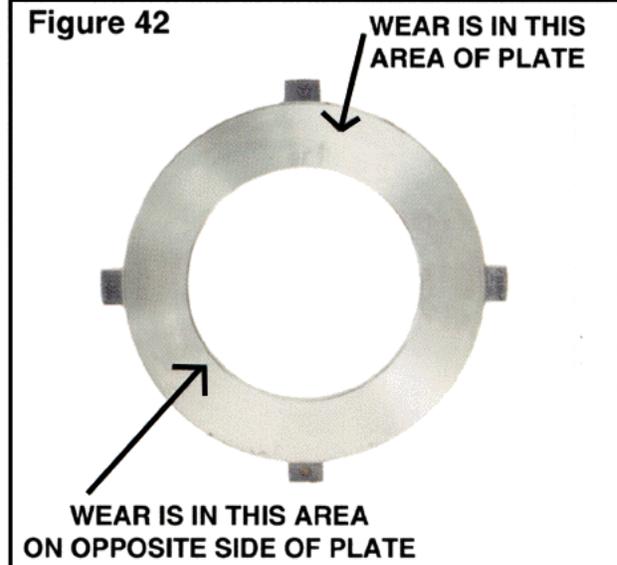
Figure 42

Wear Pattern is Not Even.

Driver Notices: Clutch drags.

Observations: Wear pattern is only in one area on both sides of center plate.

Causes: Warped or bent discs or center plate. Clutch not correctly installed.

Correction: Grind plate or replace clutch assembly. Make sure clutch is correctly installed. This condition is not covered under warranty.

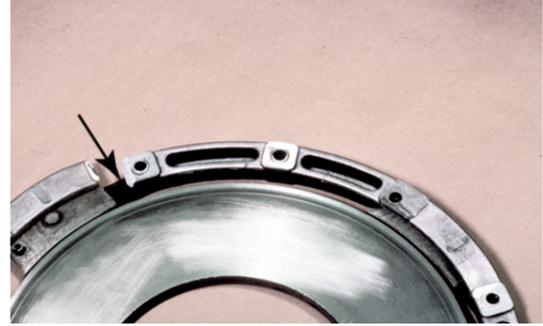
Fig 34 (SAS)

As shown in Figure 34 (see arrow), the aluminum spacer ring broke when it was bolted up backwards onto the flywheel.

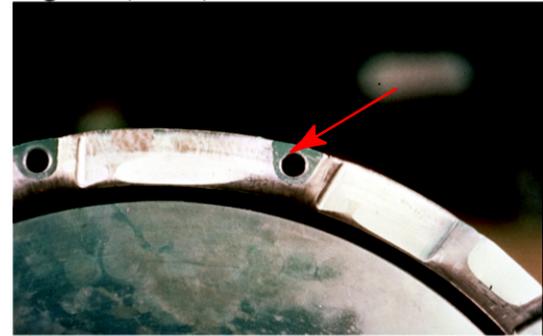
Fig 35 (SAS)

Note: The cover assembly mounting hole pads (see arrow in Figure 35) have made an indentation (see arrow in Figure 36) onto the spacer ring mounting hole pads (flywheel side). This evidence will confirm that the spacer ring/intermediate plate assembly was indeed installed backwards. The words “Flywheel side” (refer to Figure 37) will face the flywheel when properly installed. Mishandling of this assembly during installation and/or removal can also cause the spacer ring to break. Some results of installing the intermediate plate backwards are as follows:

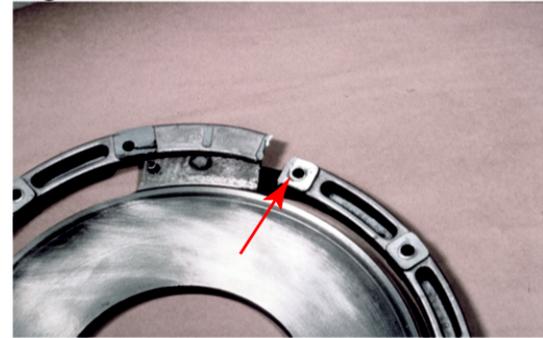
Fig 36

- A clutch that will not release properly.
- The release bearing position may be closer than normal to the transmission bearing retainer cap immediately upon clutch installation.
- A “cracking” noise as you tighten the (8) mounting bolts that secure the cover to the flywheel.

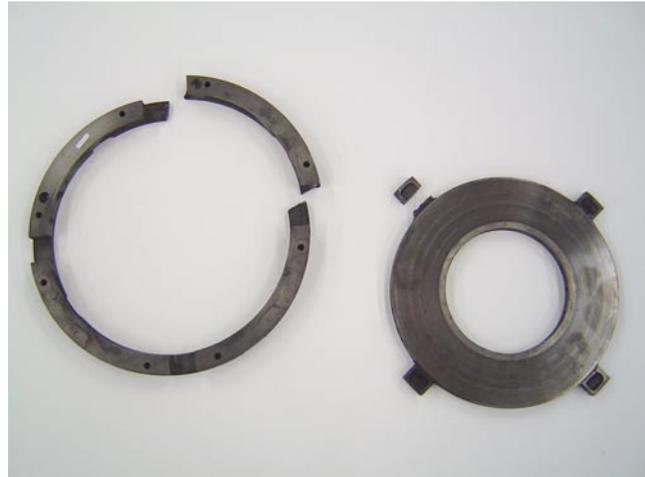
A broken conversion ring (CR) or intermediate plate lug in a stamped angle spring clutch results from the mechanic installing the conversion ring in backwards. Weight has been removed from the backside of the conversion ring similarly to the machined intermediate plate guide slots on the pressure plate side for balance. When drawing in the mounting bolts to proper torque, either the intermediate plate lug or the conversion ring will break if the ring is in backwards. The correct "Flywheel Side" is marked on the ring.

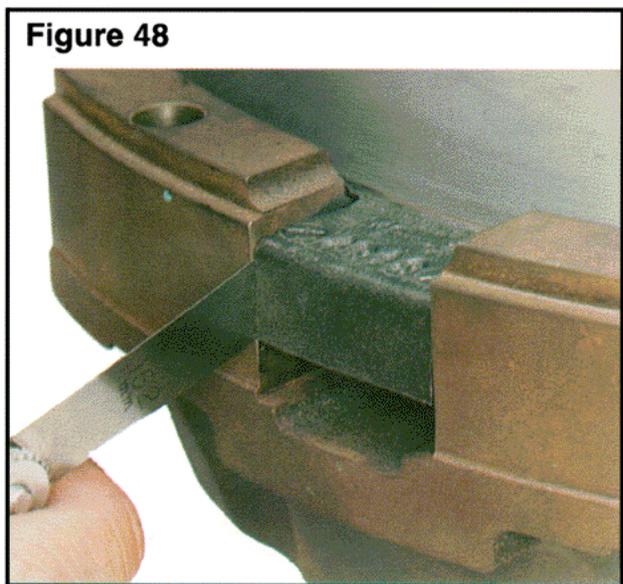
Damaged Tabs (15-1/2 Inch Clutch)

Driver Notices: Clutch is noisy. Clutch may be difficult to engage and disengage.

Observations: Tabs are worn or damaged. The clearance between the tab and the slot in the clutch housing is less than 0.006 inch (0.152 mm).

Causes: Drivetrain vibration.

Correction: Replace the center plate. Correct the cause of drivetrain vibration. This condition is not covered under warranty.

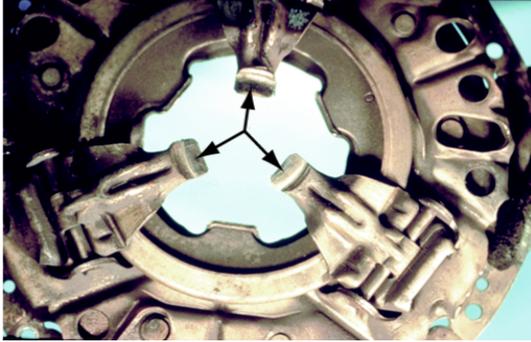
Fig 38 (AR)

Failure - Lever Wear

As indicated by arrows in Figure 38, excessively worn levers are most likely the result of lack of maintenance. More specifically, lever wear can be the result of one or more of the following conditions:

- A dry, seized, or broken throw out bearing. Typical causes of a damaged bearing are:
 - a. Operating the truck without free-play
 - b. Constant riding of the clutch pedal

Both items 1 and 2 can cause the thinning and loss of bearing lubricant. They can also cause rapid lever wear due to constant contact with the bearing.

- A throw out bearing which fits too tightly on the front bearing cap stem. As a result, the return spring(s) (attached to the linkage or throw-out bearing) may not be capable of retracting the throw-out bearing away from the clutch levers. This will cause contact between these parts.
- Worn and/or binding linkages are causing the throw-out bearing to make “constant contact” with the clutch’s three (3) release levers (Figure 38).
- Using a throw out bearing of inferior quality.

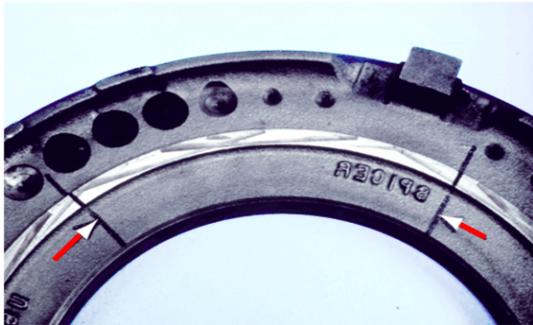
Fig 39

Figure 39 shows the back of the pressure plate. This clutch has been properly adjusted (internally, using the adjusting ring) because each of the 6 levers has more than one witness mark (or lever fulcrum point).

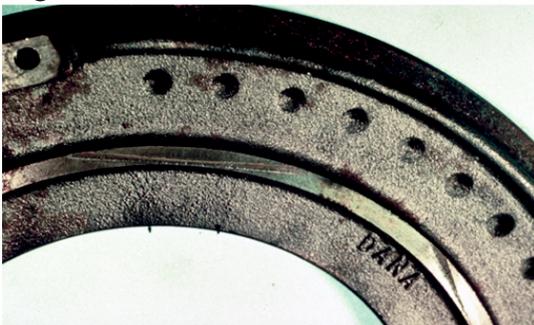
Fig 40

Figure 40 depicts a clutch that has not been adjusted properly. As shown, there is only one witness mark per lever indicating that the clutch was improperly adjusted using the linkage.

WARNING: Continually adjusting for clutch wear via the linkage can lead to the failures shown in Figures 4, 5, 25, and 57-58.

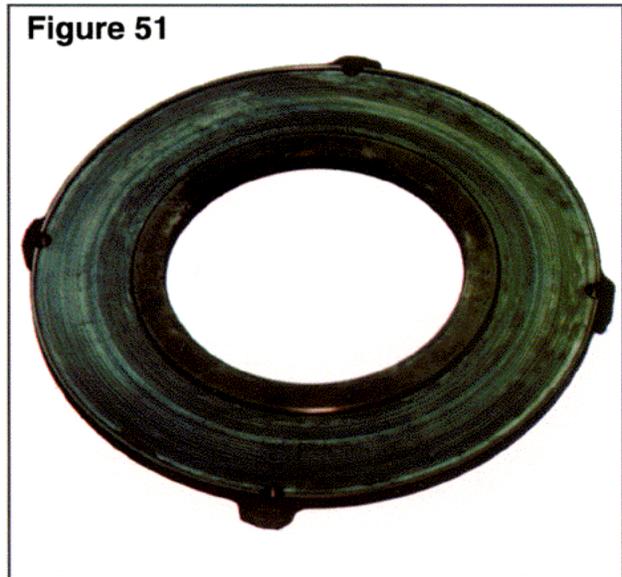
Normal Wear

Normal wear is smooth and even.

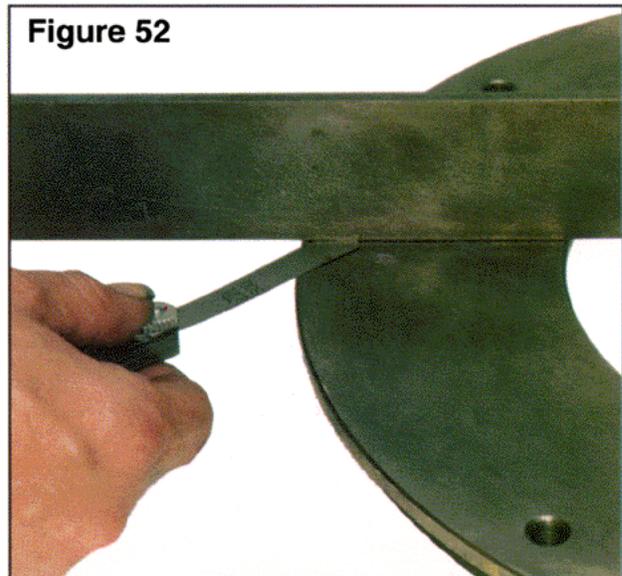
Wear Pattern is Not Even.

Driver Notices: Clutch slips.

Observations: Wear pattern is only in one area with some heat damage.

Causes: Warped or bent pressure plate. Clutch not correctly installed. The plate is warped if the taper is more than 0.005 inch (0.127 mm).

Correction: Replace clutch assembly. Install clutch correctly. This condition is not covered under warranty.

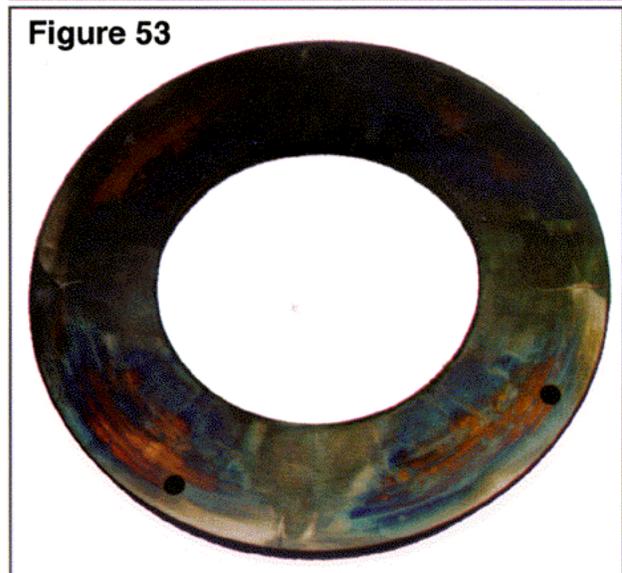
Broken or Cracked

Driver Notices: Clutch slips and is difficult to engage or disengage. Clutch is noisy.

Observations: Pressure plate is cracked on the surface or is broken. Plate is severely burnt.

Causes: Excessive heat build-up, slipping or the clutch is out-of-adjustment or not adjusted correctly.

Correction: Replace clutch assembly. Make sure clutch is adjusted correctly. This condition is not covered under warranty.

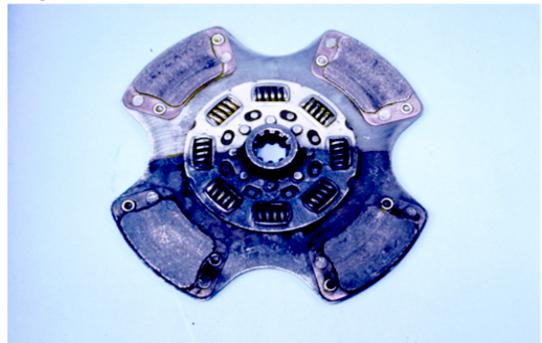
Fig 41 (AR)

Failure - Oil Soaked Ceramic Disc

After removal from the truck, the top half of this ceramic disc (Figure 41) was cleaned in order to reveal the contrast with the bottom half which is still oil soaked (Figure 30 shows the clutch cover that was run with this disc). Possible contributors to this condition are a leaking transmission and/or a leaking rear main engine seal.

Furthermore, oil on the disc buttons can cause the clutch to release poorly due to increased drag, and/or chatter/slip during engagement.

Note: Eaton does not recommend the reinstallation of any discs that are oil soaked because the button facings cannot be satisfactorily cleaned.

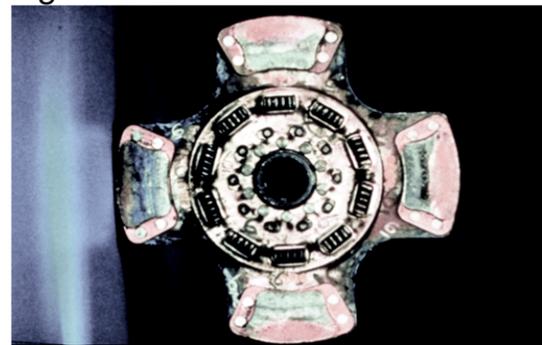
Fig 42

When troubleshooting Eaton Fuller Clutches, do not be concerned with the wear pattern (darkened areas) of the disc buttons (see Figure 42). More specifically, it is normal for the darkened areas to vary in color, size, and their relative position upon each button.

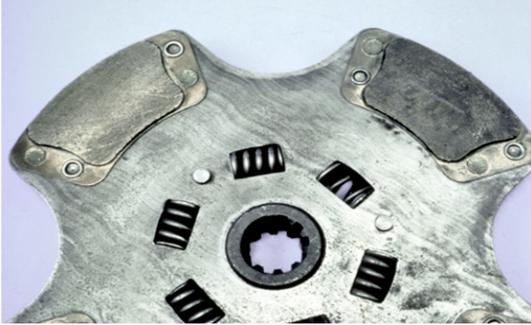
Fig 43

Failure - Grease on Buttons of Ceramic Disc

Figure 43 shows a disc with grease on its buttons, flywheel side. When this disc was removed from the truck, all four buttons had a heavy layer of grease on them. The left button has been cleaned to show the contrast with the grease-covered button on the right. Failing to remove the grease (rust preventative) from the flywheel (new or resurfaced) can cause this problem.

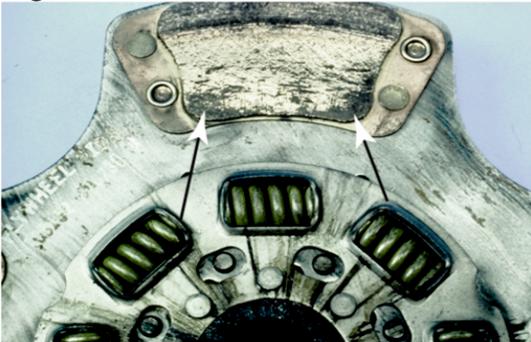
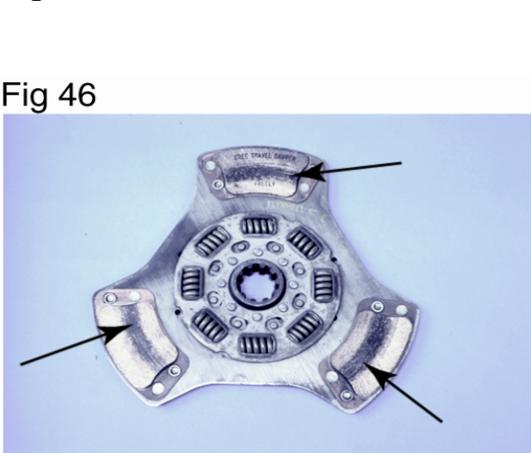
Greasing the splined areas of either the input shaft or disc hub(s) is not recommended because the grease can be spun onto the facing material of the driven disc(s) (refer to both arrows in Figure 44). The circled area in Figure 45 reveals the numerous paths which the grease took as it moved toward the buttons (facing material) of this ceramic driven disc. The photographs in Figures 44-45 are of the same driven disc.

A contaminated driven disc can cause one or more of the following problems:

- Poor release
- Clutch chatters during engagement
- Slipping clutch

Also, grease on the splined areas of the input shaft/disc hub(s) will attract dirt, worn facing material, etc. which can impede the free movement of the disc hub on the input shaft, potentially causing a "poor release" complaint.

Note: Eaton does not recommend the reinstallation of driven discs which have become contaminated with grease or oil.

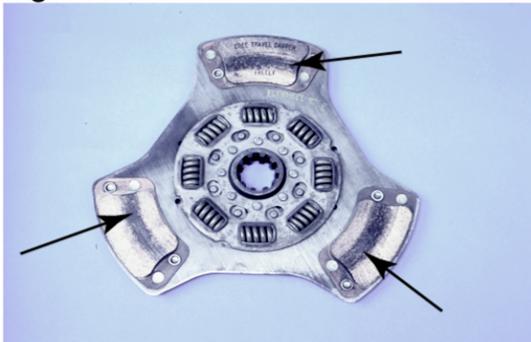
Fig 46

Failure - Abnormal Wear Pattern at Middle of Disc Button

As shown by the dark areas of the three buttons in Figure 46, this disc was making major contact at the middle of each button on the flywheel side. The buttons on the opposite side had normal wear patterns. This abnormal wear pattern is found on service clutches (not original equipment), and is usually caused by a flywheel that is worn unevenly. This condition may result from improper resurfacing of the flywheel.

Before resurfacing any flywheel, consult your OEM service manual for proper procedures.

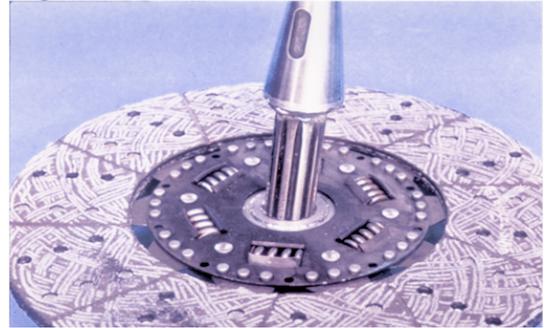
Fig 47

Failure - Warped Driven Disc

Shown in Figure 47 is a brand new driven disc which was warped during transmission installation (as indicated by the dummy input shaft which is not perpendicular to the disc's hub). More specifically, the transmission was allowed to hang unsupported in the driven disc hub. A driven disc which has become bent due to improper installation techniques should not be reused because of the potential for a "poor release" complaint.

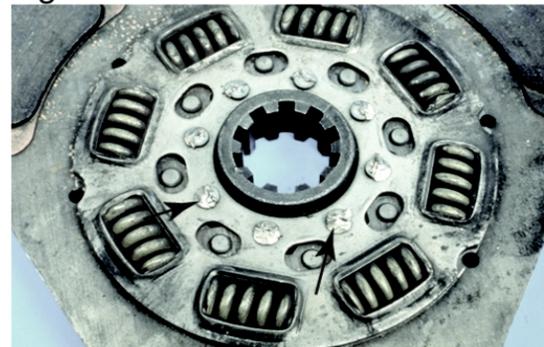
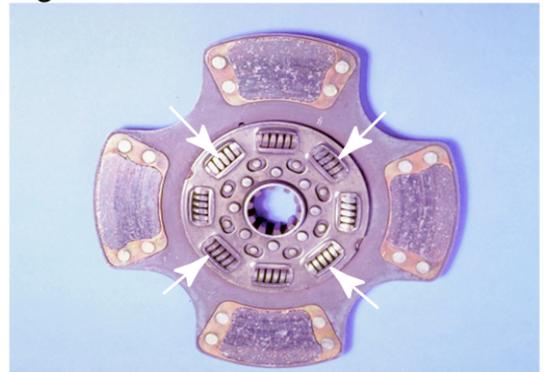
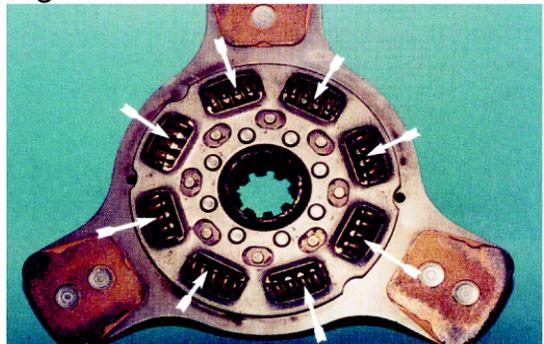
Failure - Front Disc and Flywheel Interference

- The rivets of the disc (Figure 48) have been contacting the flywheel's mounting bolts. Some potential causes of this particular interference are as follows:
 - a. Loose flywheel mounting bolt(s) due to inadequate torquing.
 - b. Forgetting to tighten one or more of the mounting bolts when reinstalling the flywheel.
 - c. Installing an extra washer under the flywheel mounting bolt.
 - d. A flywheel which has been resurfaced too many times.
- The damper springs (see arrows, Figure 49 and 50) have been contacting the flywheel mounting bolts because the front driven disc was installed backwards. The driven disc (in Figure 49) had been wearing for a period of time before the interference occurred (as indicated by the full wear pattern on the ceramic buttons) while the one in Figure 50 was run for a very short period.

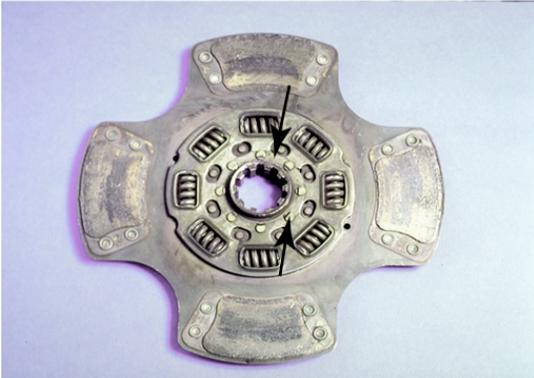
Fig 51

- A disintegrating pilot bearing which is interfering with both the hub and rivets of the driven disc (Figure 51).

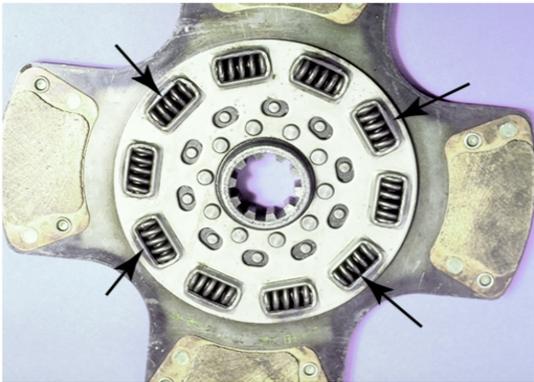
Fig 52

- Installation of the wrong clutch. Figure 52 (see arrows) shows the points of interference that resulted when a 10-spring driven disc was installed where an 8-spring was previously being run. In other words, the recessed area of the flywheel (mounting bolt cavity) was too small for the 10-spring driven disc. Before you mount the new clutch, consult the Eaton Installation Instructions (packaged with each Eaton Fuller Clutch) concerning "potential damper interference". A driver complaint, resulting from the above failure, can be:
 - a. The clutch does not release
 - b. The clutch is noisy during operation

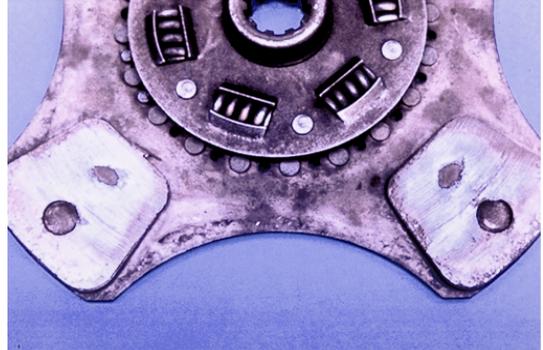
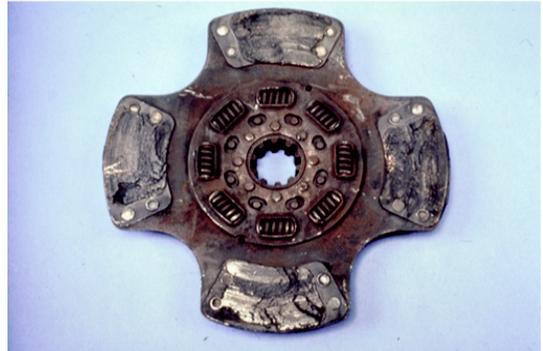
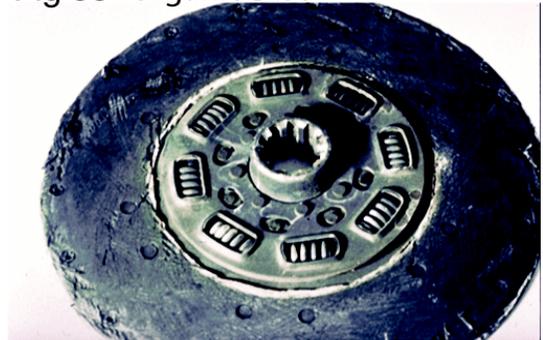
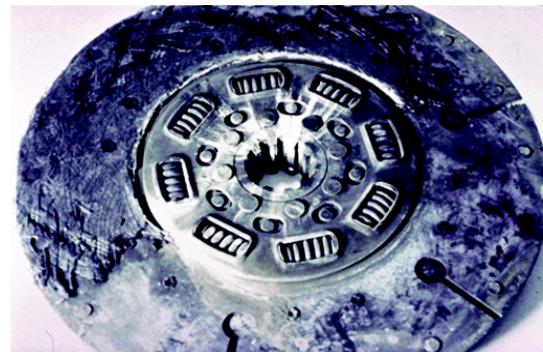
Failure - Burnt Discs

The failures shown in Figures 53-56 and 58 are the result of excessive heat due to prolonged slippage. Figures 53, 54, and 58 show discs that became so hot (due to slippage) that the ceramic material began to flow and eventually separate from the disc. Figures 55 and 56 show how the organic material separates from the disc due to bonding agent failure as a result of extreme heat. Burnt discs may result from:

- Lack of free pedal
- Constantly riding the clutch pedal
- Utilizing a slipping clutch as a brake on an incline
- Partial unloading of a clutch due to a binding linkage system, interference, etc.
- Installation and use of improper clutch (wrong application)
- Worn driven disc facings

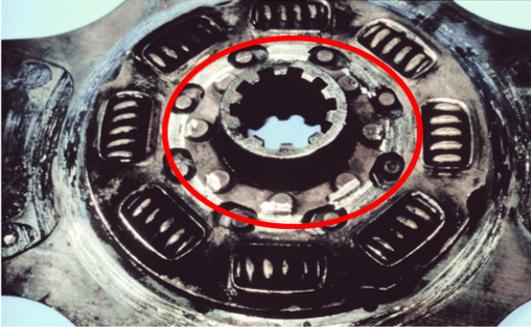
Fig 57

Failure - Rear Disc Interfering with Retainer Assembly

Figure 57 (see circle) shows the damage that will occur to the rear disc when it makes contact with the retainer assembly (refer to the arrow in Figure 25 concerning the subsequent damage to this part). This type of interference was so great that the clutch began to slip while engaged, thus creating enough heat to cause the ceramic buttons to self-destruct (Figure 58).

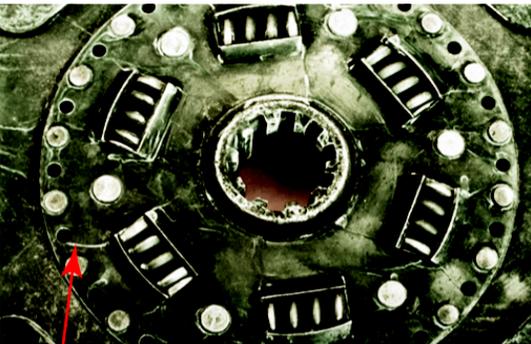
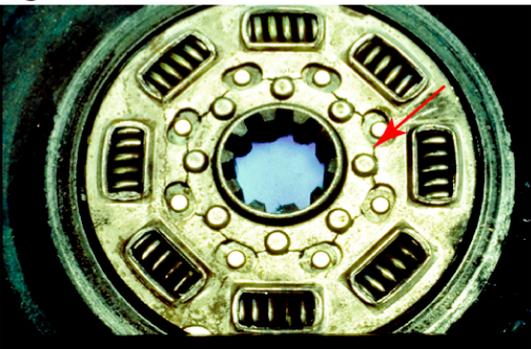
Failure - Cracked Damper Cover

The cracks shown in Figures 59 and 60 (see arrows) can result from:

- Forcing the transmission input shaft into the disc hub during installation
- Allowing the transmission to hang unsupported in the driven disc(s) during installation
- Misalignment between the engine housing and the transmission bell housing

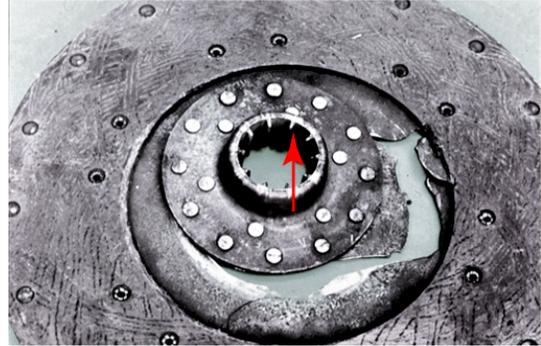
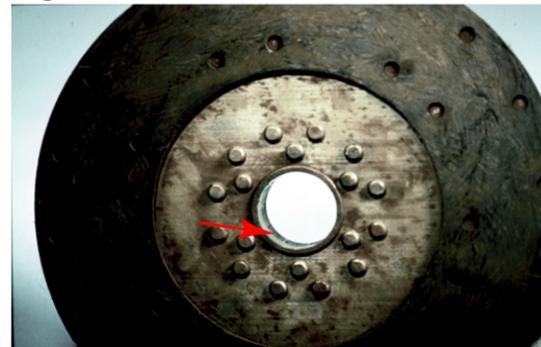
Failure - Hub of Rigid Driven Disc Worn Excessively or Fractured

Figure 61 shows a disc hub that has worn excessively (see arrow) and has also broken away from the disc. Note the narrow width of each spline compared with those on a new disc. Figure 62 reveals a hub in which the splines have been completely “pounded” out (see arrow.) The typical cause of worn splines is either torsional vibrations or misapplication of the clutch. A broken or cracked disc hub can be attributed to one or more of the following:

- A severe shock load, such as engaging the clutch while coasting down a hill.
- Misalignment between the transmission bell housing and engine housing due to loose transmission mounting bolts and/or worn mating faces of either housing.
- Misapplication—a rigid disc should not have been used, but rather a dampened disc assembly (D.D.A.).
- Torsional vibrations from the engine.
- Excessive flywheel runout.
- Allowing the transmission to hang unsupported in the driven disc during installation.

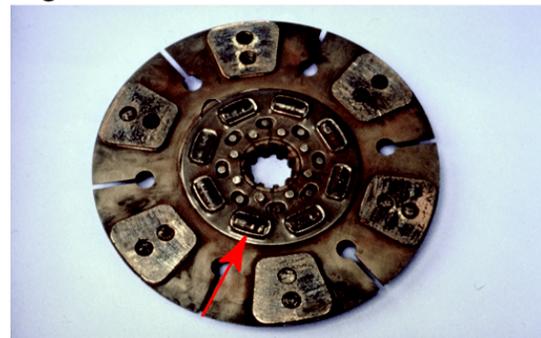
Fig 63

Failure - Non-Eaton Fuller Material

Figure 63 is the disc of a non-Eaton rebuilt clutch. It is an old disc that was rebuilt, as indicated by the presence of dampener springs encased in rubber (see arrow). Consequently, the rubber covered springs can make the disc act as a rigid disc, thus increasing wear to the input shaft and the disc itself. As shown by an arrow in Figure 64, parts of this disc have broken. Also, the springs are wrapped in rubber to prevent any worn ones from falling out after the disc is put into service. Contrast this with the Eaton Fuller Reman Clutches in which only new discs are used.

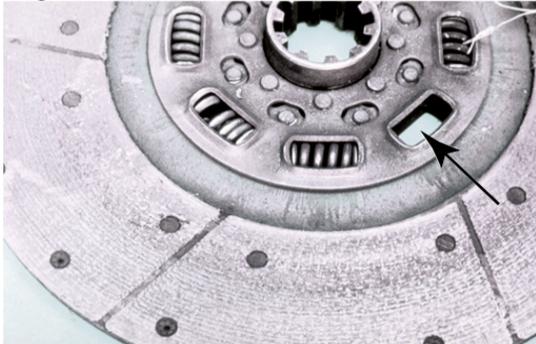
Fig 66

Failure - Broken and/or Missing Dampener Springs

A broken dampener or missing spring (see arrow in Figure 66) may result from severe shock loads or excessive torsional vibration from the engine in excess of what the dampener springs can absorb. If the clutch disc is not original equipment, verify whether it matches the vehicle's application.

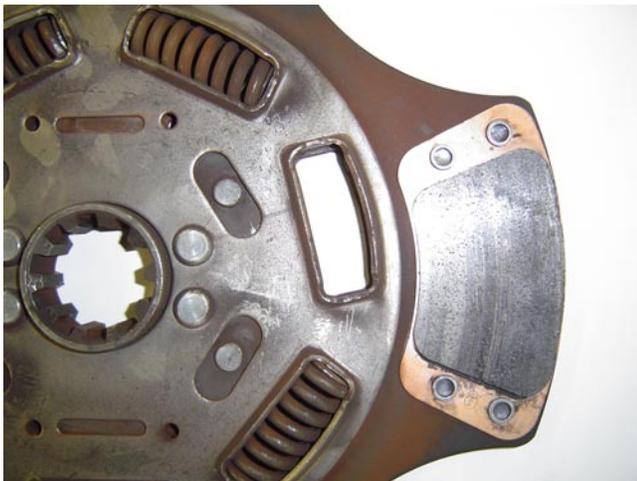
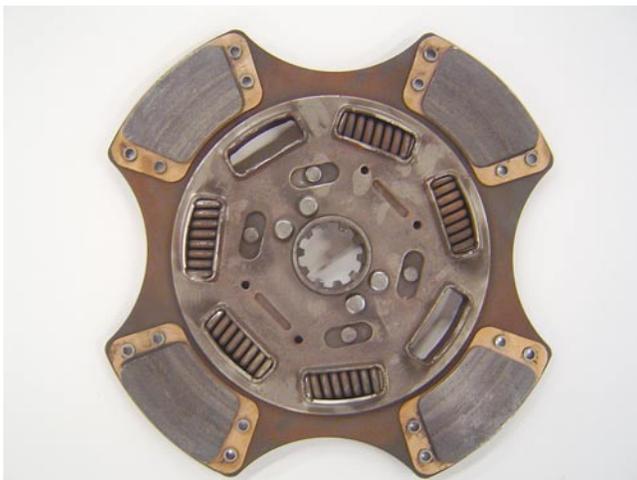
- Misapplication is the primary reason for the springs to break and come out of a disc spring cage. The spring cage window will become egg shaped over time and the dampening capability of the disc will decrease prior to failure.
- Driver abuse due to: starting in too high a gear; shock load from downshifting improperly to the wrong gear; letting the clutch out too quickly; or coasting and putting the clutch into gear while engine and rear RPM are not at the same rate will contribute to clutch disc damage and/or failure.
- Broken springs in a disc may also be the result of the disc spring cage rubbing against the heads of the flywheel mounting bolts. This may result from a flywheel that has been machined too deep, or a mechanic having used too thick a lock washer under the flywheel mounting bolt.

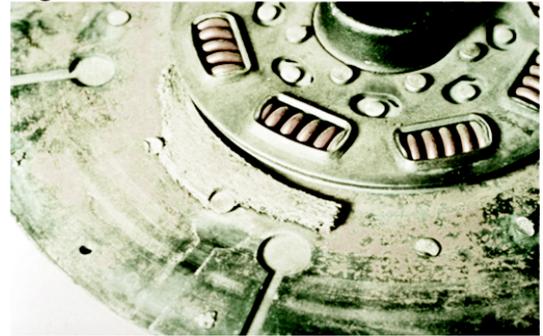
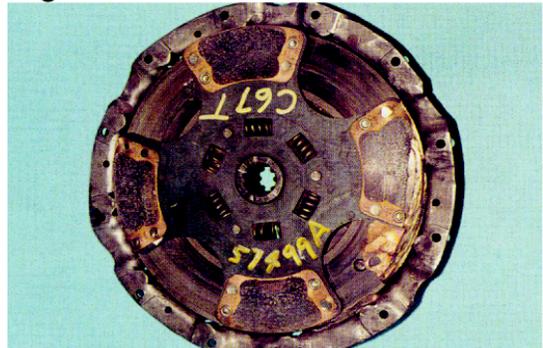
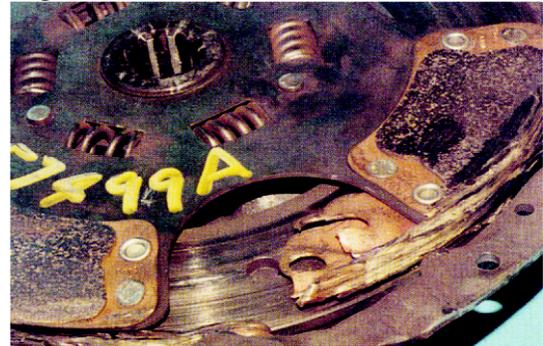
Failure - Burst Driven Disc, Friction Material Separates from Disc

This type of failure is caused by very high RPM encountered when coasting in gear with the clutch released. In this situation, the rear wheels are driving the disc through the multiplication of the rear axle and transmission ratios. This can result in excess of 10,000 RPM which is beyond the burst strength of the facing material.

Example: Coasting a tractor down an unloading ramp can burst a driven disc. See Figures 67, 68, and 69.

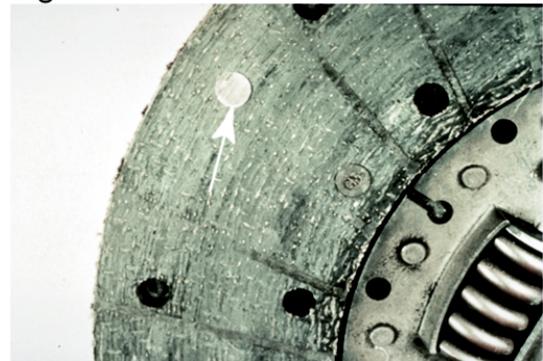
Fig 70

Failure - Worn Driven Disc Facings

When the rivets (those which secure the facing material to the driven disc) begin to contact either the pressure plate, intermediate plate, or flywheel, then the entire clutch assembly is ready for replacement. Referring to the arrow in Figure 70, this rivet has been making contact with the pressure plate shown in Figure 17. Note the “shiny” appearance of the rivet and also the resulting “groove” on the pressure plate.
