Heavy-Duty Brake Drums

Maintenance & Installation Manual

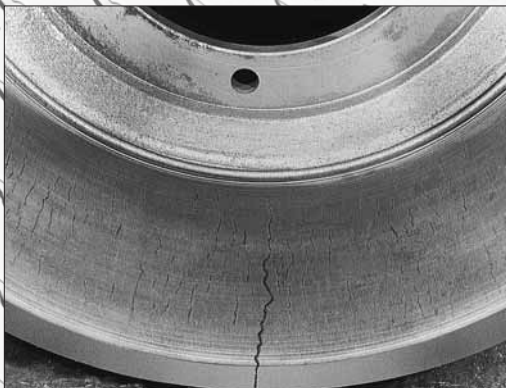
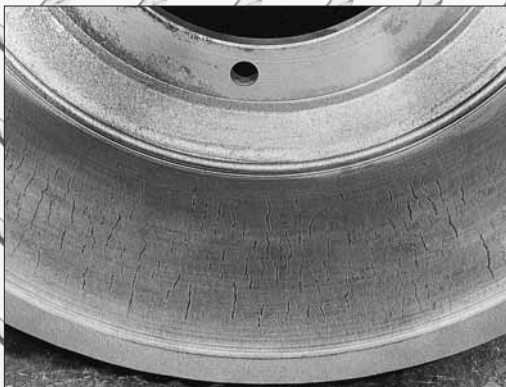
Normal heat-checking does not impair braking performance, however, it is advisable to make sure that deep cracks have not developed. Replace the brake drum if any of the following conditions are found: heat checks, one or more that extend completely across the brake surface. Heat check cracks that are 0.06 inches wide and/or 0.12 inches deep or greater.

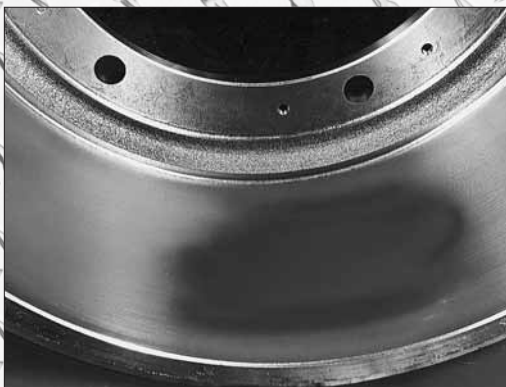
GREASE-STAINED DRUMS

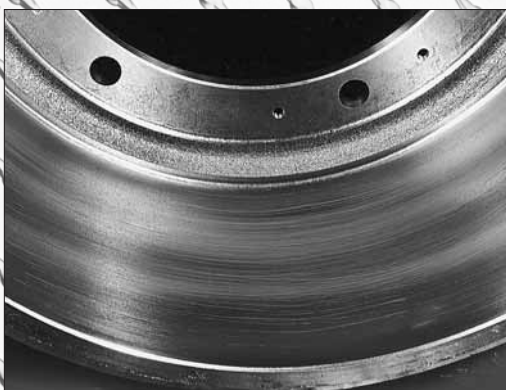
After replacing the brake drum, the entire braking system should be checked for proper balance between the tractor and the trailer as well as wheel to wheel (i.e., air distribution, brake adjustment, and power A/L factors).

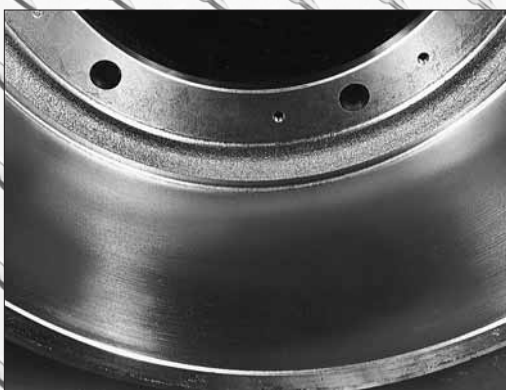
NOTE: WHEN CHECKING BRAKE DRUM DIAMETER FOR WEAR, THE DIAMETER SHOULD NOT EXCEED .120" OVER THE ORIGINAL DIAMETER. WHEN REBORING BRAKE DRUMS, THE FINISHED DIAMETER SHOULD NOT EXCEED .080" OVER THE ORIGINAL DIAMETER.

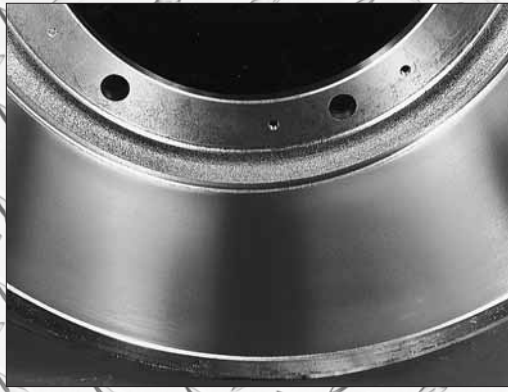
If this condition is left unresolved, it can result in the development of a martensite condition or cause the drum to crack.

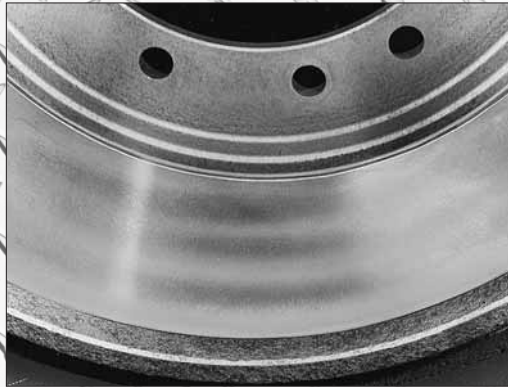
NOTE: IT IS A RECOMMENDED PROCEDURE TO SAND THE BRAKING SURFACE OF THE DRUM AT THE TIME OF RELINING.

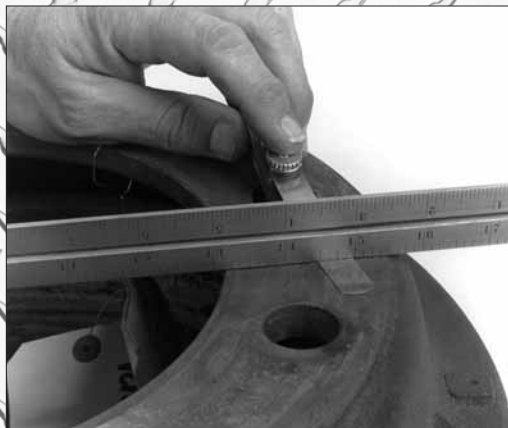
WORN MOUNTING SURFACE

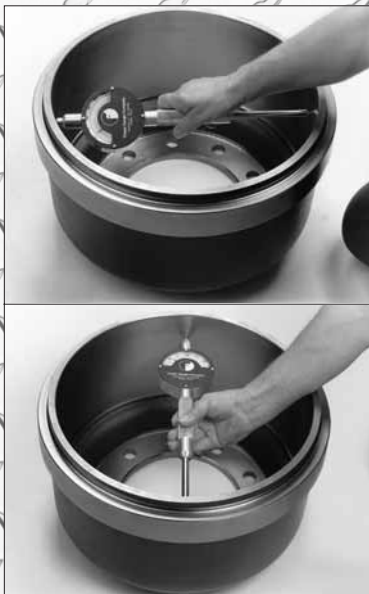
Rounding over of the drum-mounting surface is caused by continued operation with a loose wheel assembly. If this condition is left uncorrected it will cause the wheel bolts to break resulting in wheel-end failure and the loss of the wheel assembly. To check for this condition use a straight edge and a feeler gage as shown. If the wear exceeds .030", the drum must be replaced along with all wheel bolts in the assembly.

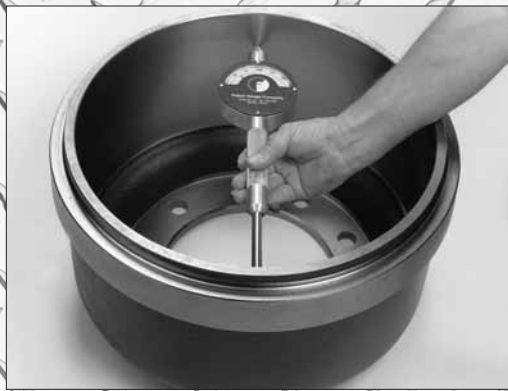
OVERSIZED (WORN) DRUMS

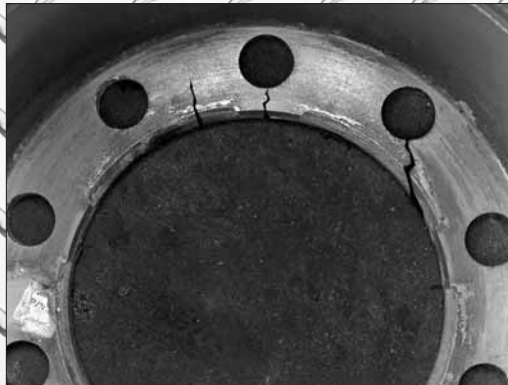
Radial cracking of the boltholes on the mount surface:

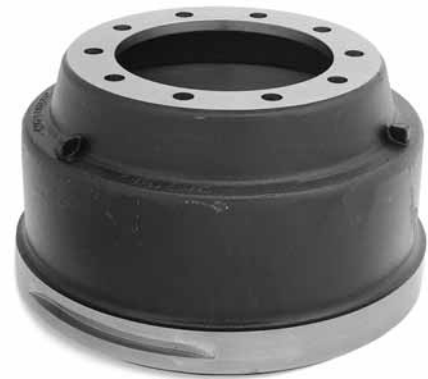
Welded balance weight

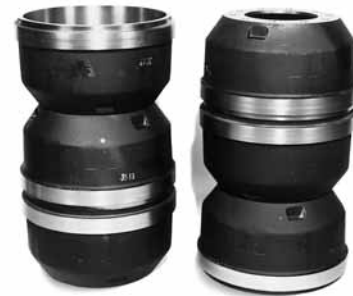
Drums should be stored in an area free from excess moisture and stacked as shown in Figure 1, to ensure proper distribution of weight on the sidewalls of the drum. Properly stacking new drums will avoid distortion of the sidewalls or damage to the braking surface.

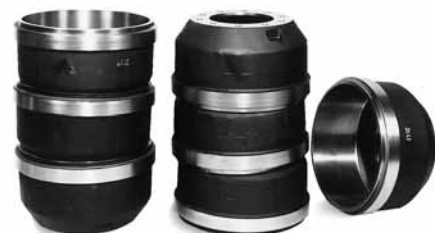
Storing brake drums by "nesting" one drum in another or resting the drums on their side "book end", as shown in Figure 2, will result in damage to the drums. Storing drums in any of these ways will cause an out-of-round condition to occur which will require machining to restore concentricity before installation. This will significantly reduce the service life of the drum and create unnecessary expense due to the machining of a new drum.

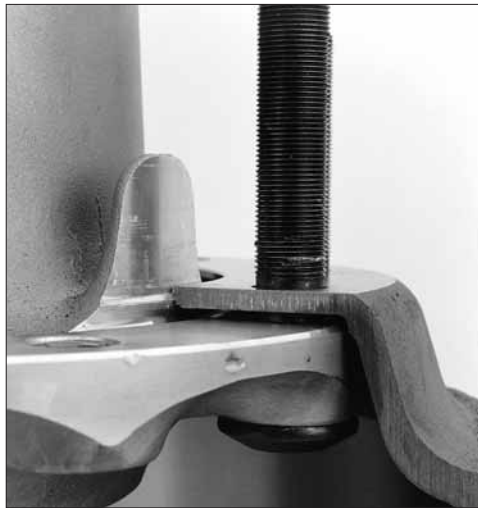
Figure 6 - Improper installation, drum is cocked and not properly seated on the drum pilot of the hub.

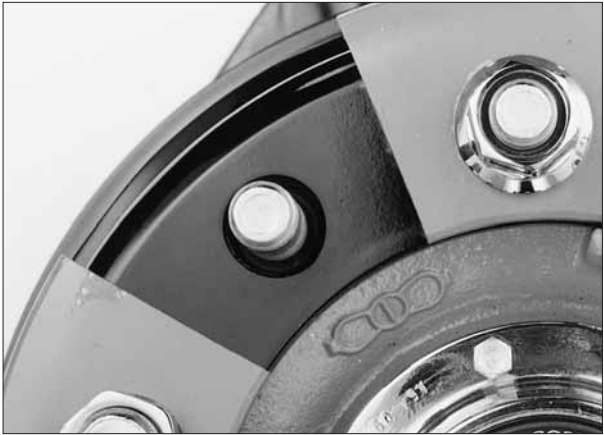
1-1/4" Bolt Hole Front Steer Axle Application
