Brake Drum Wear Conditions

Brake Drum Failure Analysis

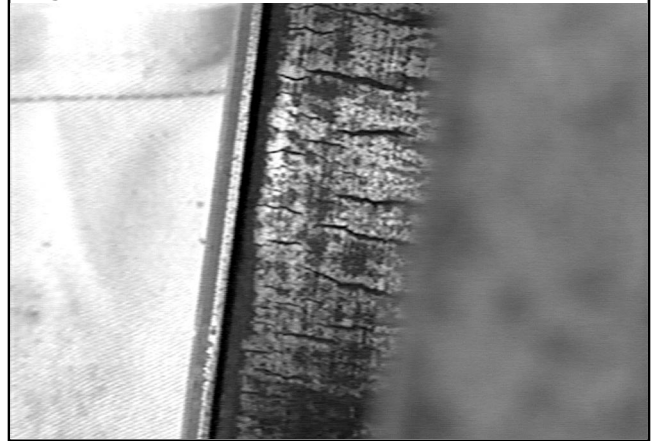
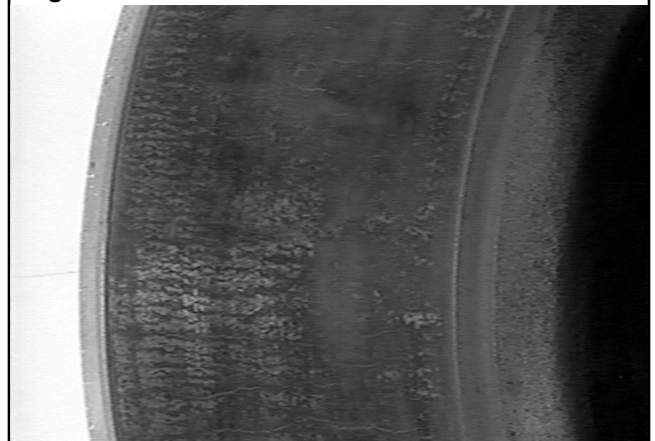
Deep, Uniform Wear

Deep, uniform wear at the edge of the drum where the lining rub path starts can result from brake drag, brake imbalance and dirt embedded in the brake lining. **Figures 6.1 and 6.2.**

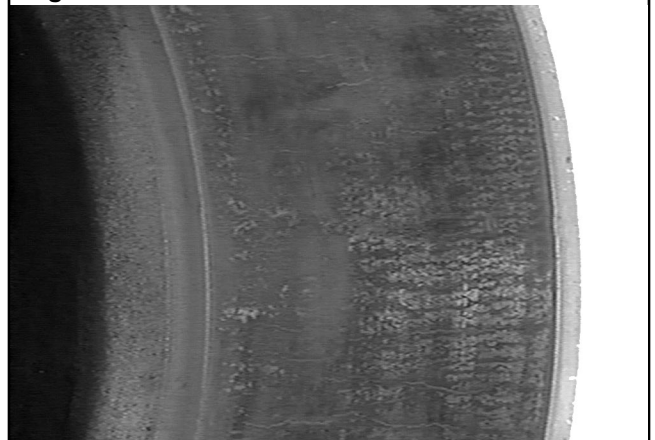
Figure 6.3

Deep Wear on One Side of the Drum Only

Deep wear only on one side of the drum indicates that the drum is not concentric with the bearing center line of the hub. No evidence of hot spotting may be evident. **Figure 6.3.**

3. Check that the brake drum surface is concentric to the bearings within 0.015-inch (0.381 mm) total indicator runout (TIR). Excessive end play can result when the drum's surface is not concentric to the bearings, which can result in deep drum wear on one side only.
4. Inspect all components for corrosion before assembly, especially the brake drum pilot and mating hub and bolt flanges. Corroded parts can cause excessive end play, which can result in deep drum wear on one side only.

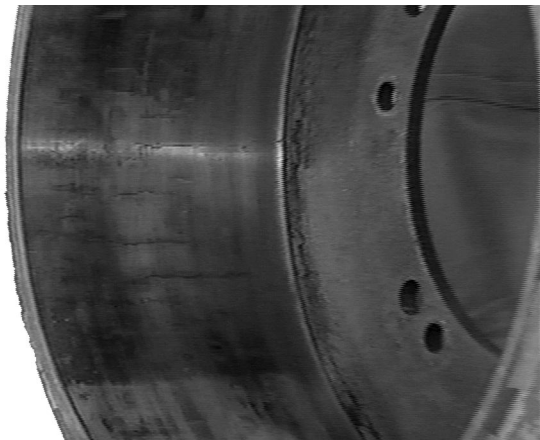
Figure 6.4

Uniform Heat Checking

Heat checking is fine cracks on the drum's surface. This is a normal condition that results from continuous heating and cooling of the friction surface. Cracks that are one to two inches or more are usually deep and require that you replace the drum. **Figure 6.4.**

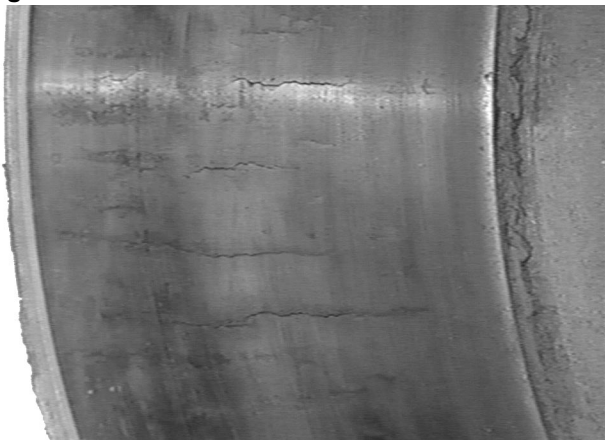
Figure 6.5

Heat Checking Only on One Side of the Drum

Heat checking that appears only on one side of the drum results when a drum is not concentric to the linings. Hot spotting may or may not be evident. However, you may also notice deep wear on the same side of the drum. Replace the drum. **Figure 6.5.**

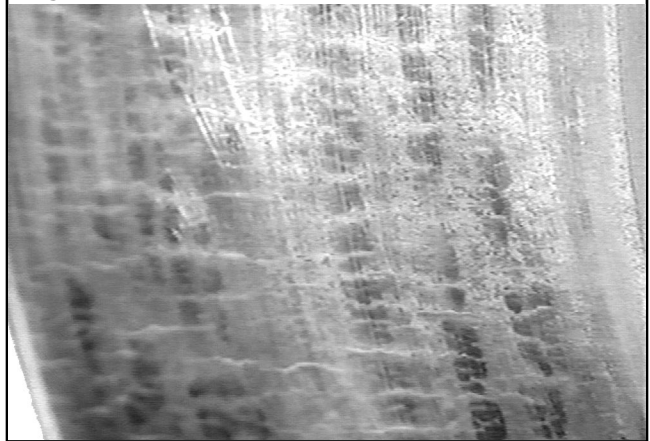
Figure 6.6

Hot Spotting (Black Spots)

Hot spotting is black spots on a drum's surface that can appear in the following ways:

1. Over the entire surface (uniform). **Figure 6.6.**
2. On one side only. **Figure 6.7.**
3. In three equally distant places. **Figure 6.8.**
4. Replace the brake drum.

Uniform hot spotting (black spots) on the drum's surface	Brake lining and drum mating surfaces burnished too slowly Brake drag Extremely hard linings Lining swell from poor-quality linings	Replace the drum.
Hot spotting (black spots) on one side only	Brake drum not concentric to the lining Drum dropped, bent or machined out-of-round Drum-to-pilot fit has too much play (gap)	Replace the drum.
Hot spotting (black spots) on three equally-distant places	Brake lining and drum mating surfaces burnished too slowly Braking with light, dragging stops Linings not OEM-approved Uneven brake surface contour caused by incorrect manufacturing process Brake drag	Replace the drum.
Polished or glazed drums (mirror-like shine)	Low-pressure braking Linings not aggressive enough or not OEM-approved	Replace the drum.

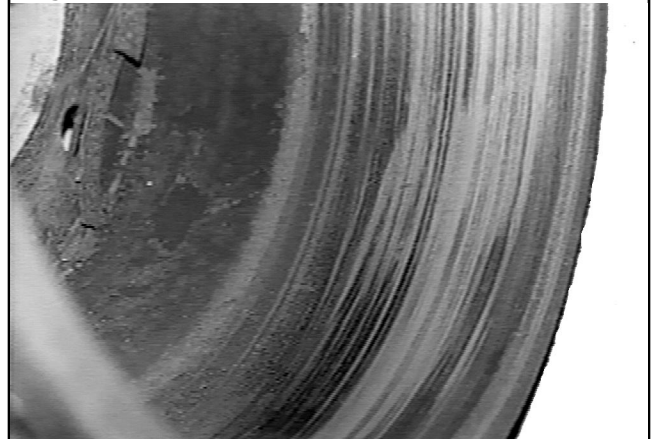
Figure 6.10

Scoring (Grooving)

Scoring (grooving) are depressions in the drum's circumference that are deeper than 0.10-inch and wider than 0.030-inch. Replace the drum and linings. **Figure 6.10.**

Condition	Possible Cause	Corrective Action
Scoring (Grooving) Deep grooves in the drum's surface that exceed the drum's maximum diameter. Drum can appear to be in good condition.	Dirt or contaminants in the brake system Linings worn to the rivets or not OEM-approved	Check for dirt embedded in the lining. Install dust shields. If dust shields are installed, remove the shields and try operating the vehicle without them.
"Blue" Drum Inside of the brake drum has "blue" tint from excessive heat. Components can be deformed or damaged.	Braking generates extremely high temperatures caused by axle-wheel end imbalance Poor driver techniques Linings not OEM-approved Brake system incorrectly spec'd for the application Brake drag	Replace the drum.
Cracked Drum Drum has cracked, but may not show signs of wear, heat checking or hot spotting.	The parking brake is set while the brakes are extremely hot. The cooling drum contracts on the brake shoes with enough force to crack the drum. Brake drum pilot interference with the hub or wheel pilot Drum cracked prior to assembly	Replace the drum.

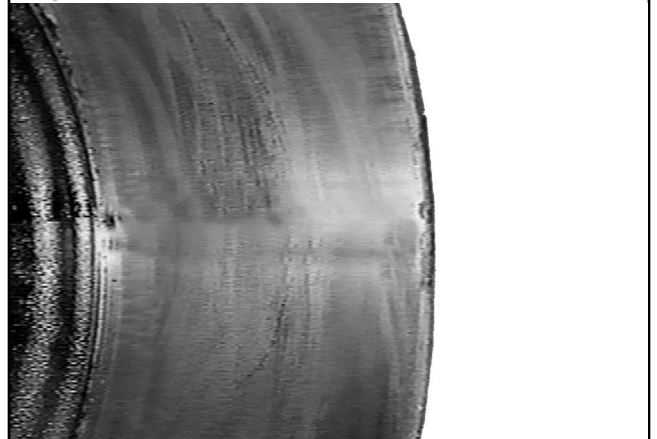
Figure 6.11

"Blue" Drum

The inside of the brake drum has a blue tint, and components can be damaged or deformed. These conditions indicate that extremely high temperatures occurred during operation. Replace the drum. **Figure 6.11.**

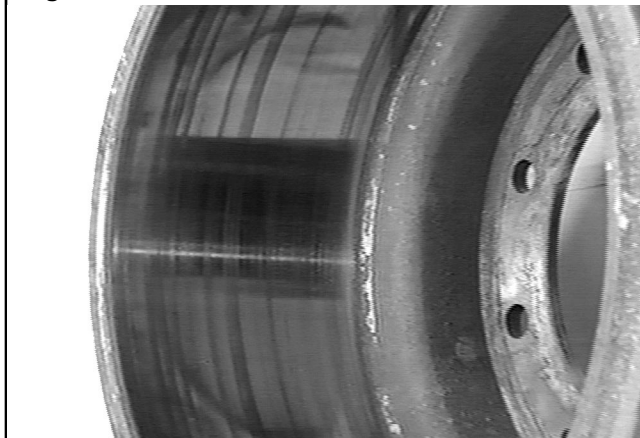
Figure 6.9

Polished or Glazed Drum

A polished or glazed drum has a mirror-like finish on the friction surface. This condition occurs with some non-asbestos linings. **Figure 6.9.**

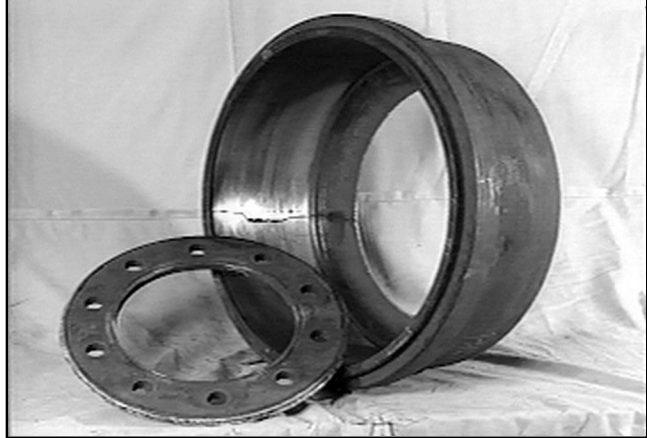
Figure 6.13

Broken Bolt Flange (Cracked Brake Surface)

The expanding brake shoes separated the bolt flange from the brake drum, but the flange remained intact. **Figure 6.13.**

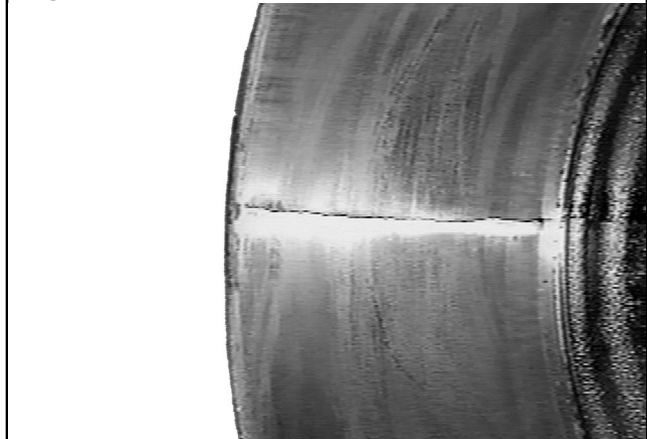
Figure 6.14

Cracked Drum

The drum has cracked, but may not show signs of wear, heat checking or hot spots. **Figure 6.14.** A drum can crack when the parking brake is set while the brakes are extremely hot. The cooling drum contracted on the brake shoes with enough force to crack the drum.

Brake drum pilot interference with the hub or wheel pilot can also cause the entire cross-section of the drum to crack, if the drum was forced onto the pilot while interference is present.

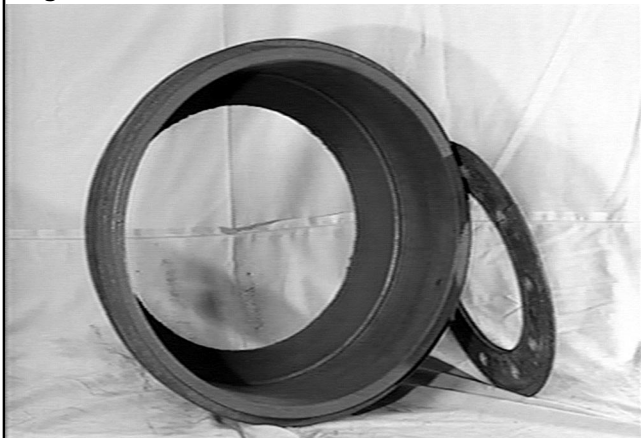
Figure 6.12

Broken Bolt Flange (Brake Surface Not Cracked)

NOTE: Allowable brake drum pilot clearance is 0.001-inch (0.0254 mm) to 0.007-inch (0.1778 mm).

The bolting flange is broken, but the brake's surface may not have cracked. **Figure 6.12.** This is a rare condition that usually has been caused by an assembly interference. For example, an incorrect drum was assembled onto a hub or spoke wheel. When the fasteners were tightened, the clamping load cracked the flange.

Broken flanges can also occur if both brake shoes do not simultaneously contact the drum.

Broken Bolt Flange (brake surface not cracked)	The brake drum pilot interferes with the hub or wheel pilot. Drum cracks at installation. High temperatures cause expanding brake shoes to separate the bolt flange from the drum Incorrect drum assembly on a spoke wheel Brake drum not seated correctly on the hub or pilot wheel Both brake shoes do not contact the drum simultaneously	Replace the drum.
Broken Bolt Flange (cracked brake surface)	Excessive wear, heat checking or hot spotting Any combination of the above	Replace the drum.
Oil or grease has penetrated the drum's surface; the drum is discolored Oil and grease spots have penetrated the drum's surface and are evident on components. Discolored drum	Wheel or hub oil seals leak	Attempt to remove oil and grease spots from the drum. If you cannot completely remove the oil and grease spots, you must replace the drum.

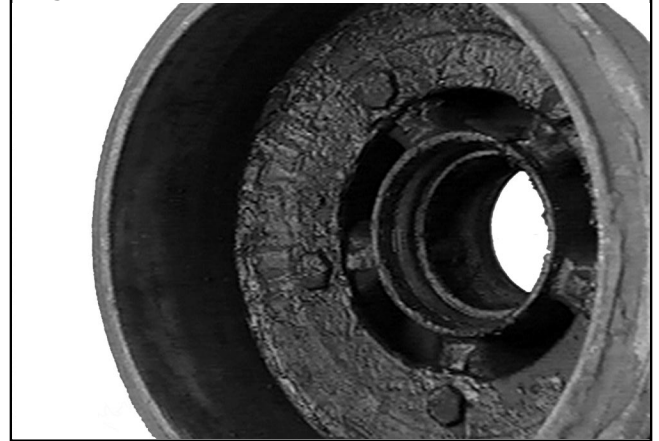
Figure 6.16

Oil or Grease Has Penetrated the Drum's Surface; the Drum is Discolored

The brake system has been contaminated with oil or grease when the following conditions are evident. It is difficult to reverse this type of damage, because oil and grease can actually penetrate iron. **Figure 6.16.**

1. Oil and grease spots have penetrated the drum's surface.
2. The brake drum is discolored.
3. Oil and grease spots are evident on components, which resulted from wheel or hub oil seals that leaked.
4. Replace the drum.

1. Clean the brake drum with a cloth dampened with water or a water-base solution.
2. **If a drum has been exposed to leaking oil or grease:** Perform Step 1. Then clean the drum with a non-oil base solvent.

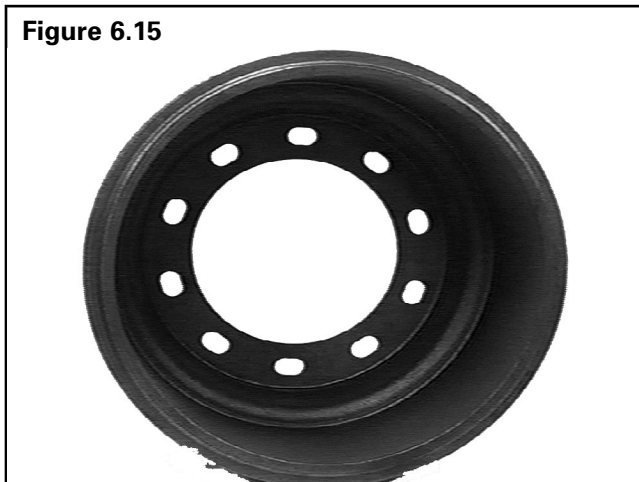
Figure 6.15

Worn Brake Drum Bolt Holes

The brake drum bolt holes are worn, usually because the bolts were not tightened to the correct torque specification. Drum pilots may also be worn, and runout in the brake drum may have occurred. The mating hub or wheel pilots may be extensively damaged. Replace both the hub and drum. **Figure 6.15.**

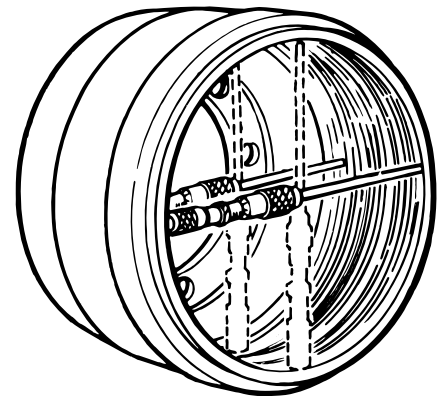
Figure 6.17

1. Closely check wear patterns on the friction surface inside the drum.
2. The maximum allowable brake drum diameter is stamped or cast into the outer edge of the drum. Place a brake drum diameter gauge inside the drum. Take several measurements within 90 degrees of each other at the open and closed edges of the drum's friction surface.
 - **If any of these measurements are 0.120-inch (3.048 mm) over nominal diameter:** Replace the brake drum. **Figure 6.17.**
 - **If a brake drum is out-of-round:** Replace the drum.

Nominal Diameter	Discard Drum At:
16.5"	16.620"
15"	15.120"
