Center Plate

Failure - Aluminum Spacer Ring on the Intermediate Plate is Broken (Eaton Fuller Solo™ and Stamped Angle Spring 1402 only)

Clutch Disc Assembly Failures

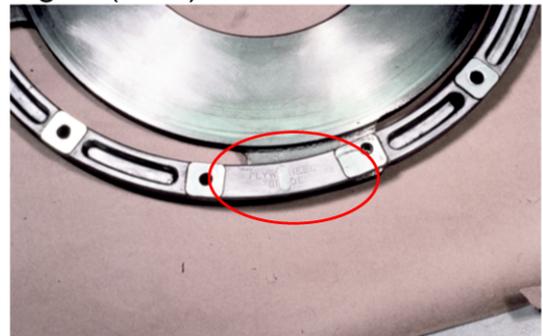
Fig 37 (SAS)

A broken conversion ring (CR) or intermediate plate lug in a stamped angle spring clutch results from the mechanic installing the conversion ring in backwards. Weight has been removed from the backside of the conversion ring similarly to the machined intermediate plate guide slots on the pressure plate side for balance. When drawing in the mounting bolts to proper torque, either the intermediate plate lug or the conversion ring will break if the ring is in backwards. The correct "Flywheel Side" is marked on the ring.
