## HCV INSTALLATION INSTRUCTIONS

P/N H14364.PM5 REV B (11/25/98)

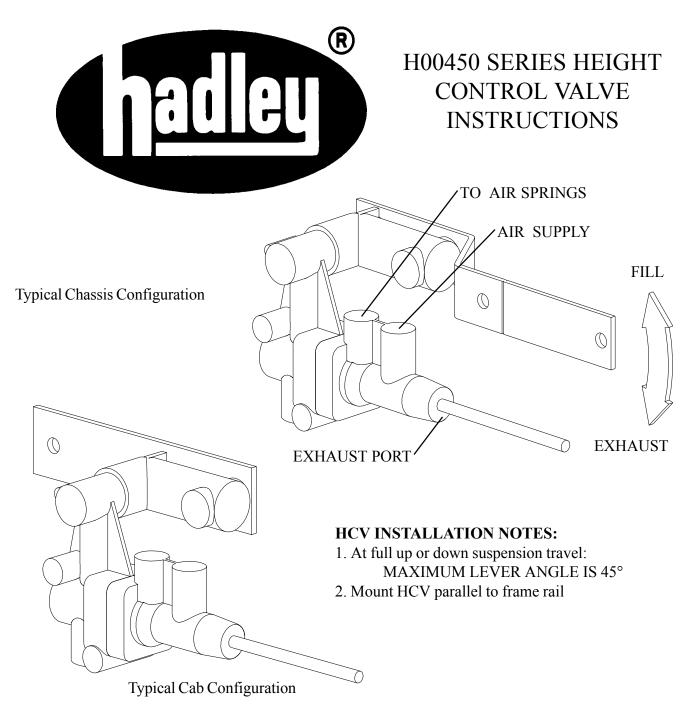
4. Reconnect the air lines to the H00450 HCV per the picture above.

2. Attach the Hadley H00450 HCV to the same mounting bracket. Or use the enclosed brackets as needed to mount the valve. NOTE: Always mount valve with the lever arm on the top side.

3. Attach the proper length lever to the H00450 HCV. Check for any interference or straight lining of the valve lever and linkage through the entire suspension travel.
